EXTERIOR WALL CONDITION ASSESSMENT REPORT

May 12, 2024

Property: [REDACTED]

Regarding: Exterior Wall Condition Assessment

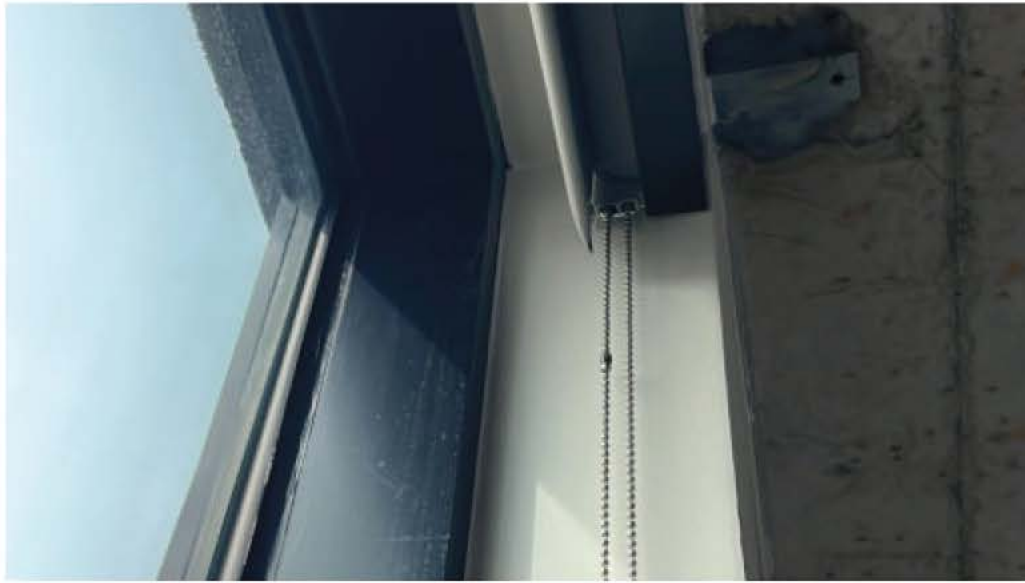
Picture 21: Common area, by air hockey table. Evidence of water intrusion

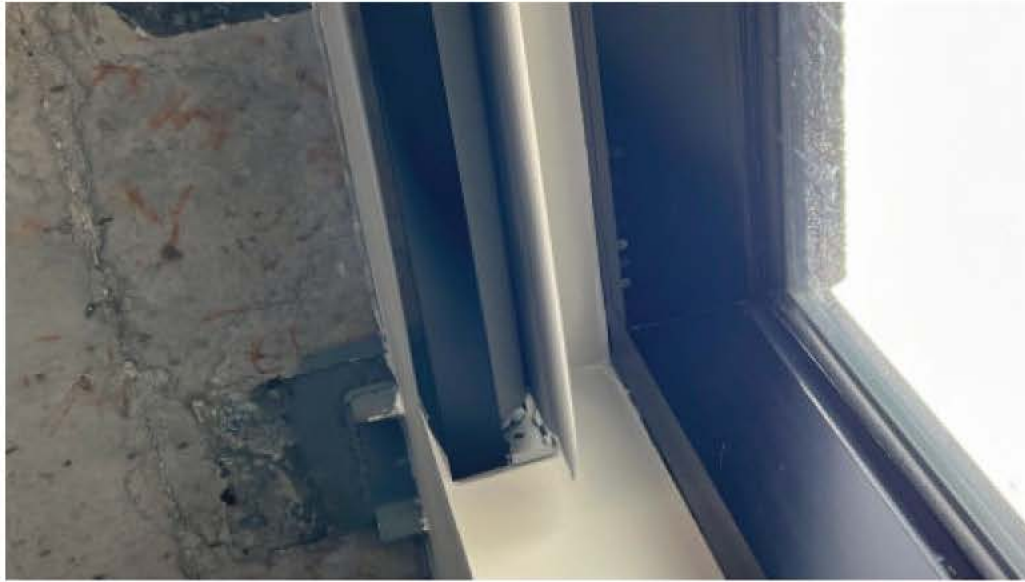
Picture 22: Common area, by air hockey table. Evidence of water intrusion

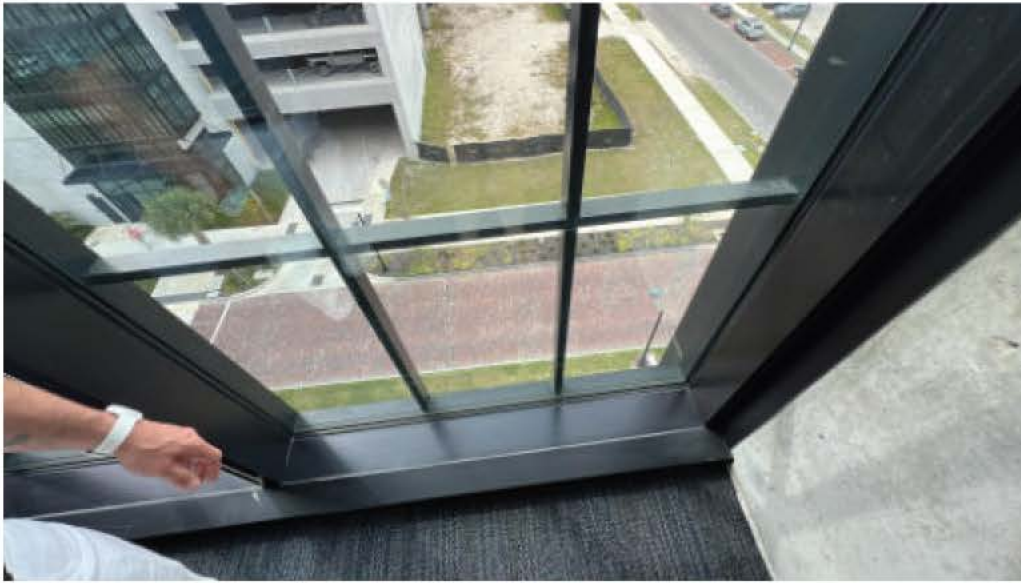
Picture 23: Common area, south elevation. Evidence of water intrusion

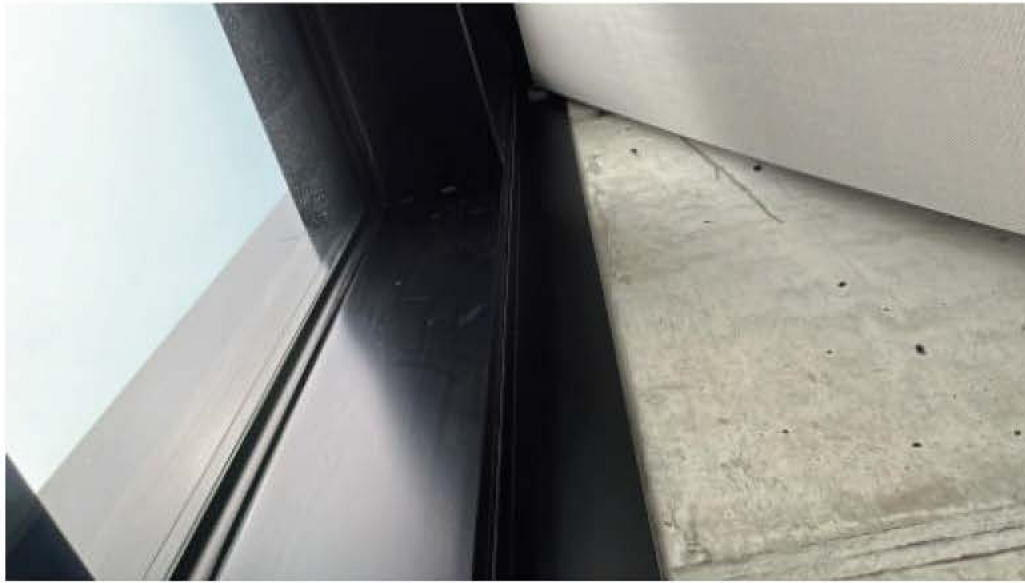
Picture 25: Common area, south elevation. Evidence of water intrusion

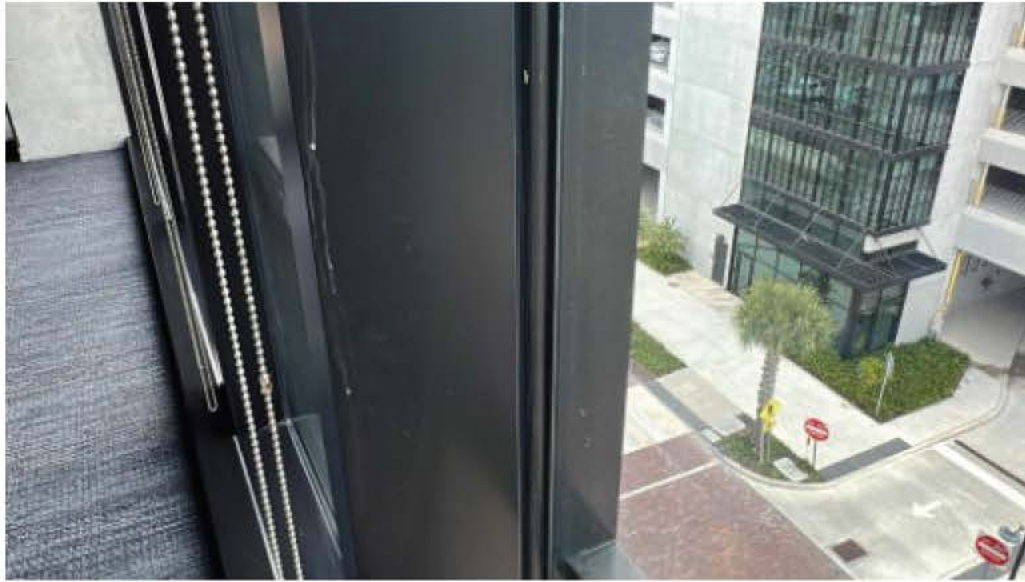
Picture 26: Common area, south elevation. Evidence of water intrusion

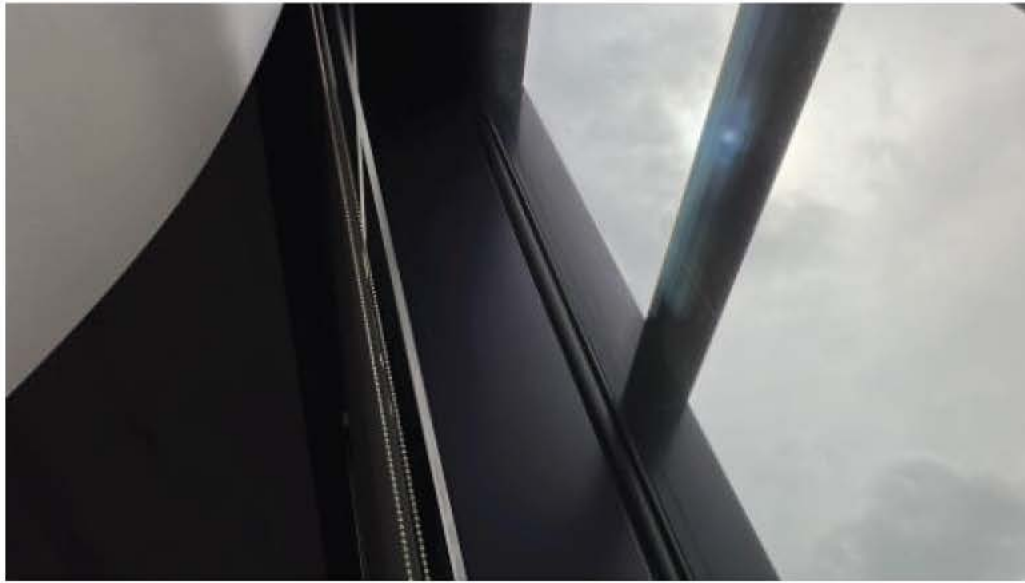
Picture 27: Common area, south elevation. Evidence of water intrusion

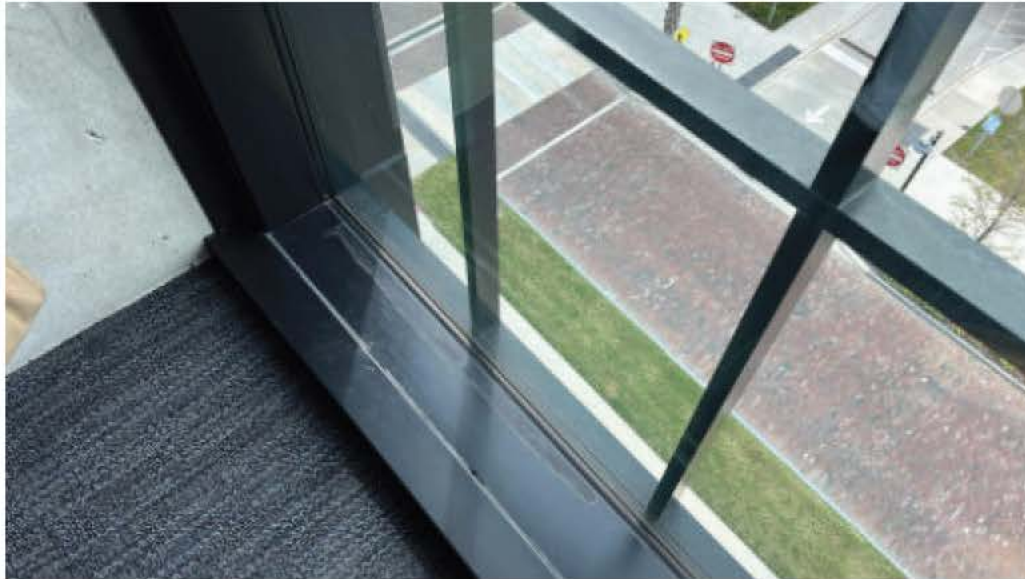
Picture 28: Common area, south elevation. Evidence of water intrusion

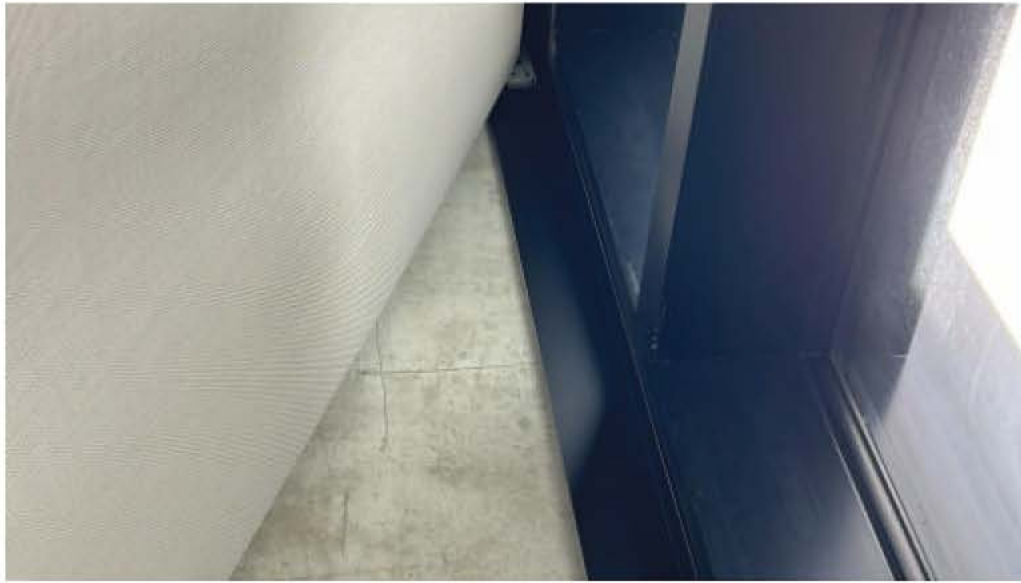
Picture 29: Common area, south elevation. Evidence of water intrusion

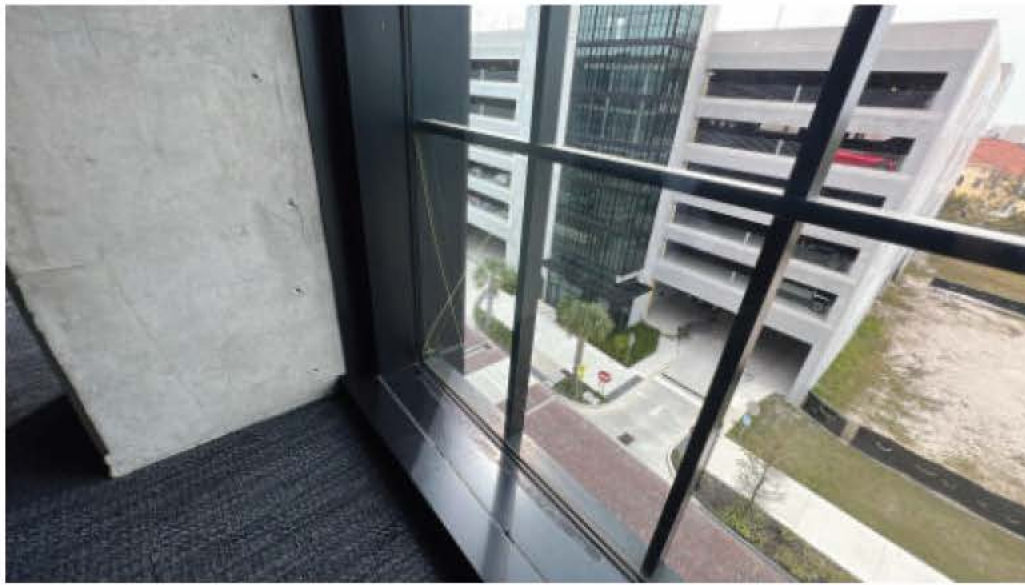
Picture 31: Common area, south elevation. Evidence of water intrusion

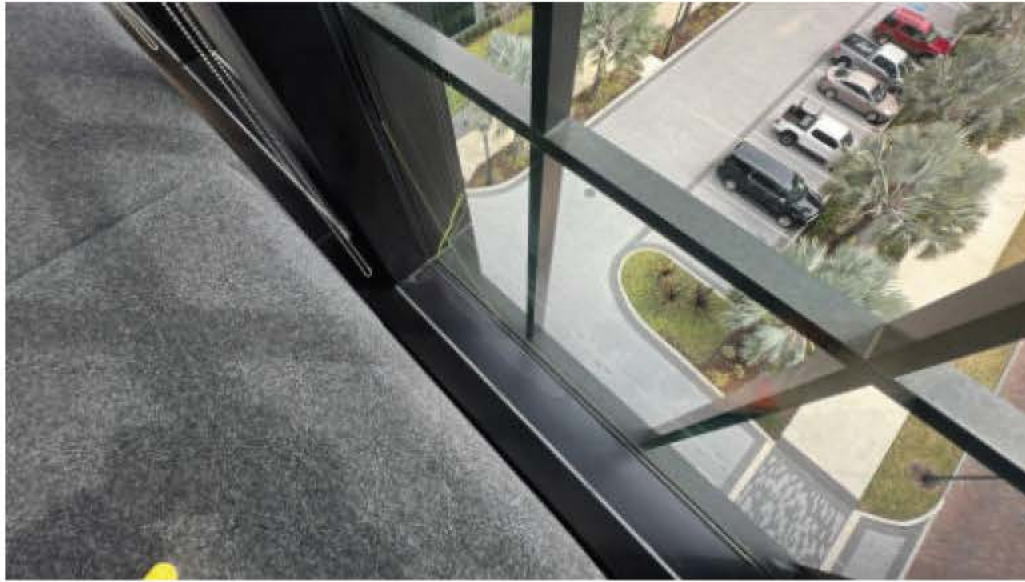
Picture 32: Common area, east elevation. Evidence of water intrusion

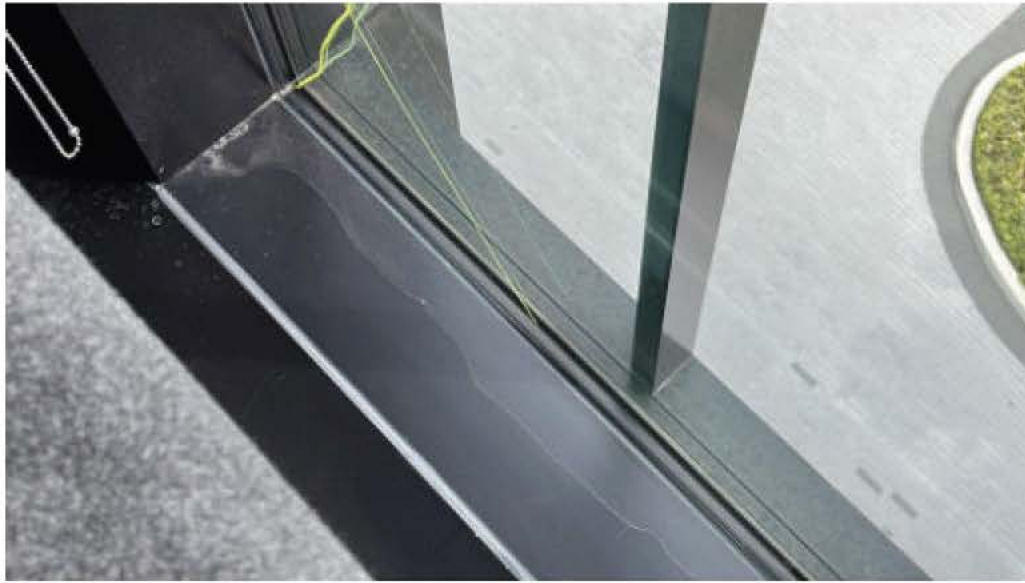
Picture 33: Common area, east elevation. Evidence of water intrusion

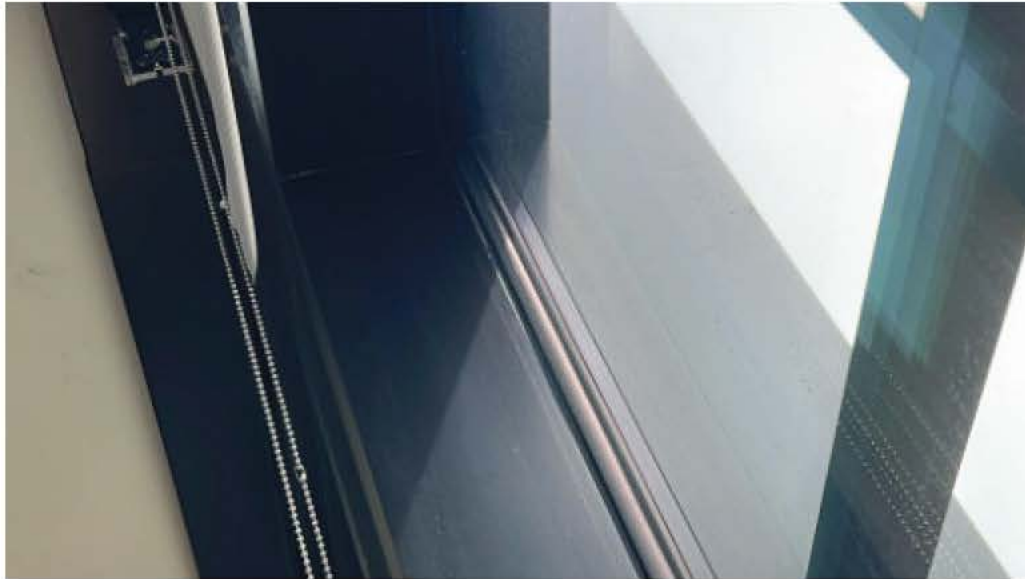
Picture 34: Common area, east elevation. Evidence of water intrusion

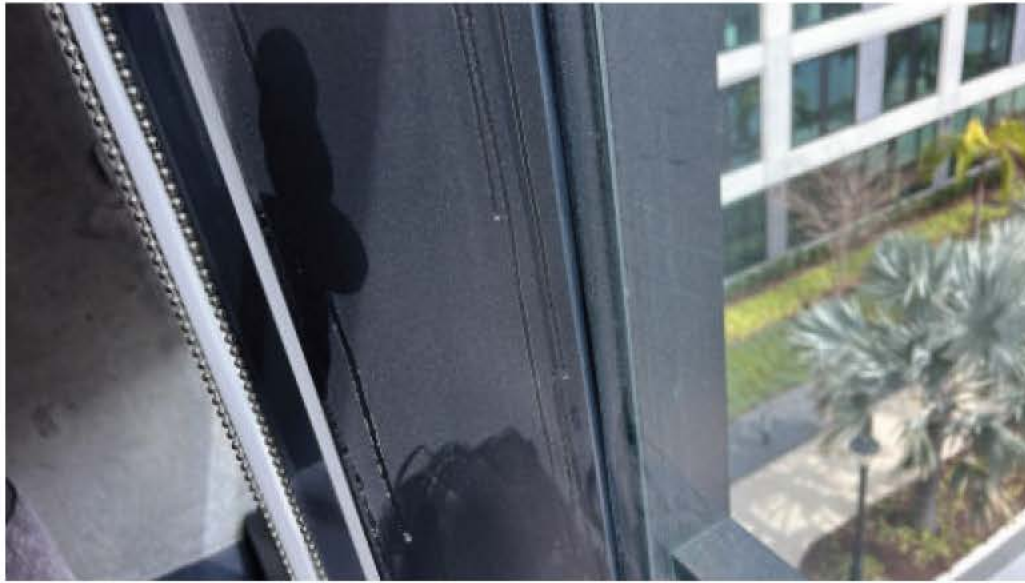
Picture 73: East elevation.
Evidence of water intrusion

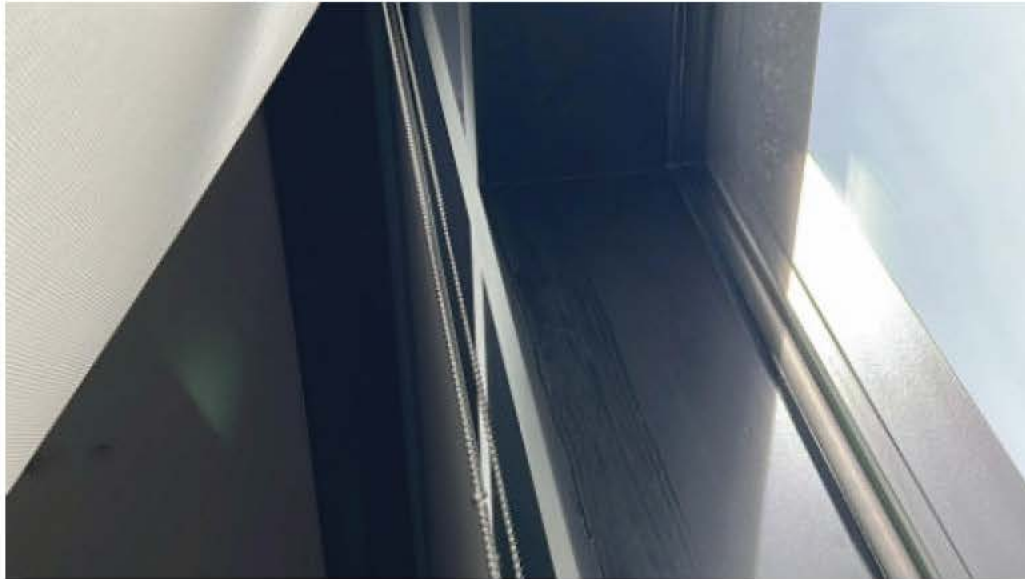
Picture 74: East elevation.
Evidence of water intrusion

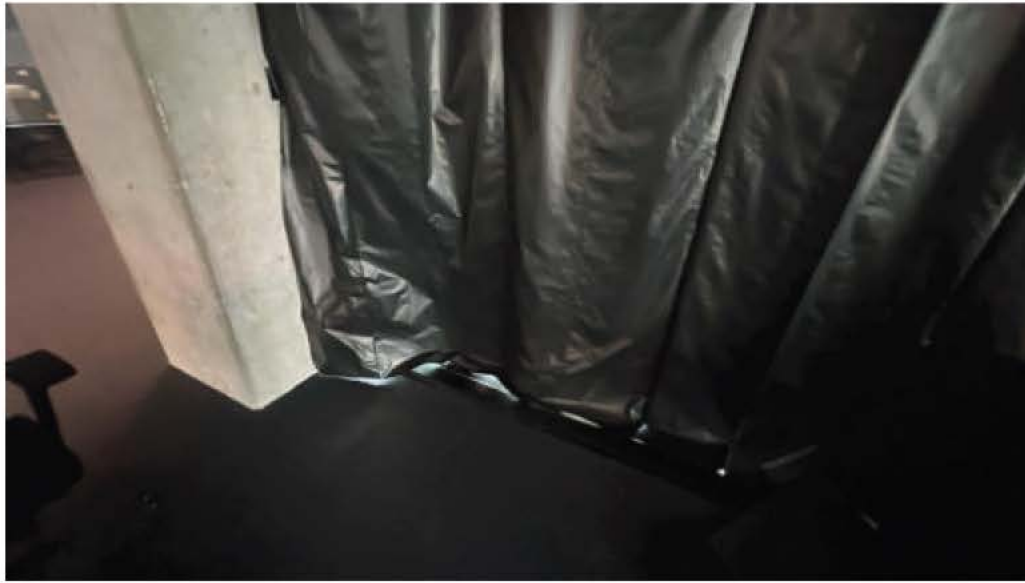
Picture 75: North Elevation.
Evidence of water intrusion

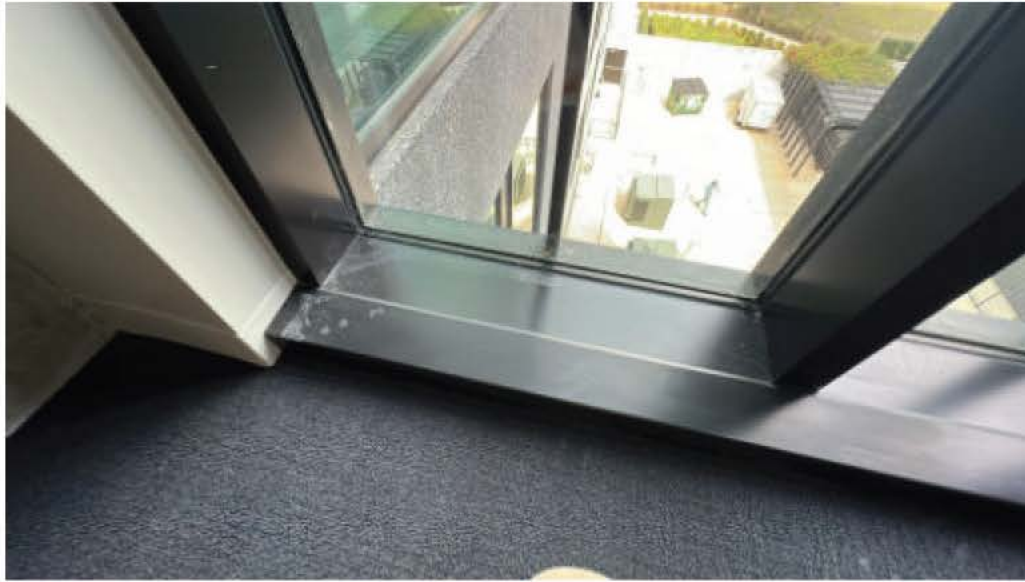
Picture 76: North Elevation.
Evidence of water intrusion

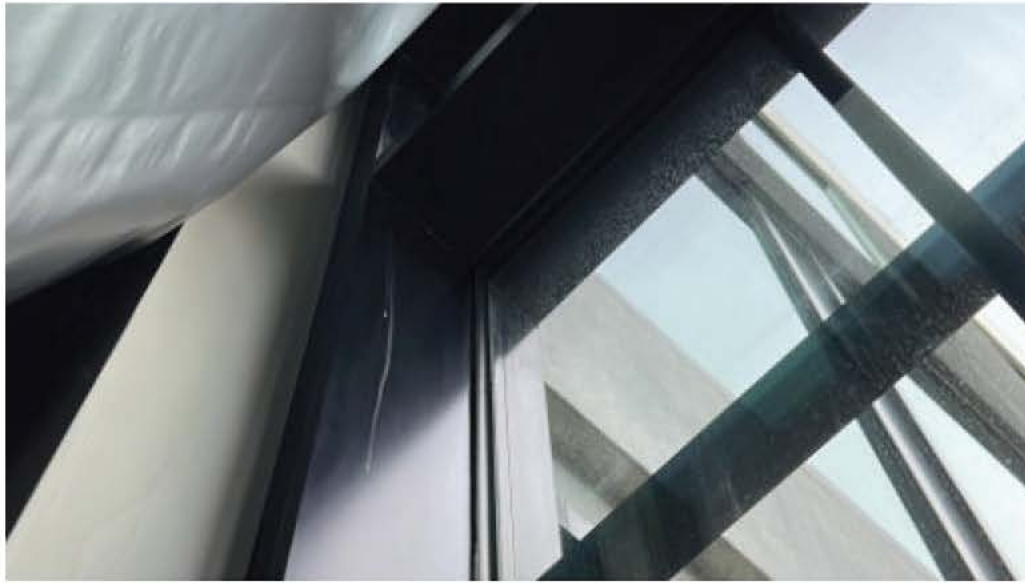
Picture 77: North Elevation.Evidence of water intrusion

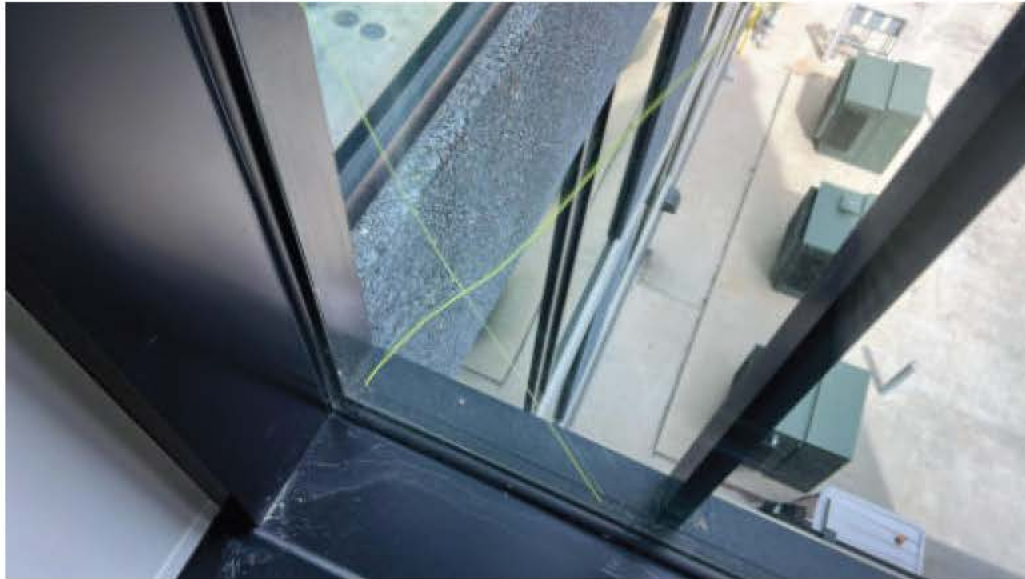
Picture 78: North Elevation. Evidence of water intrusion

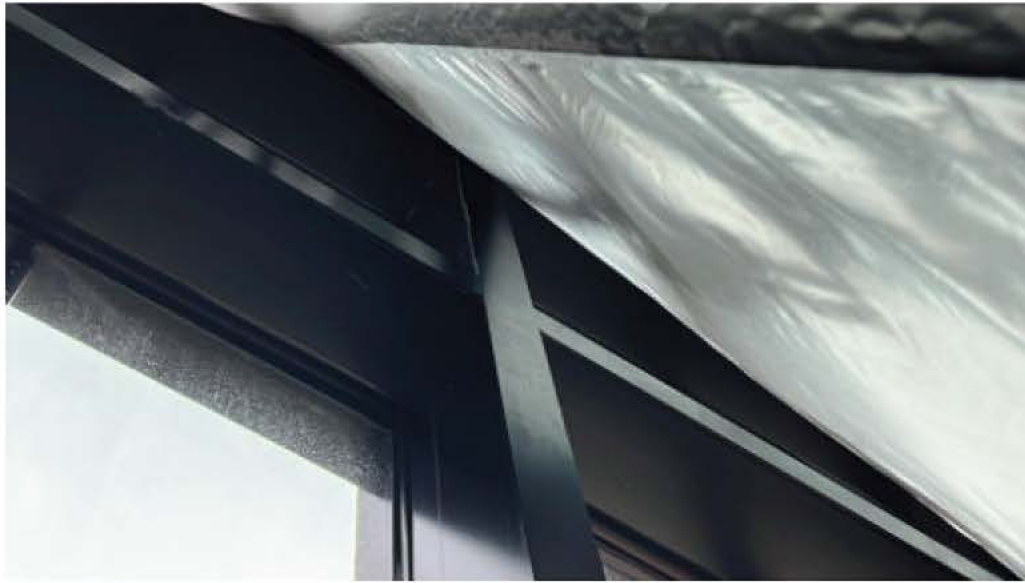
Picture 79: North Elevation.
Evidence of water intrusion

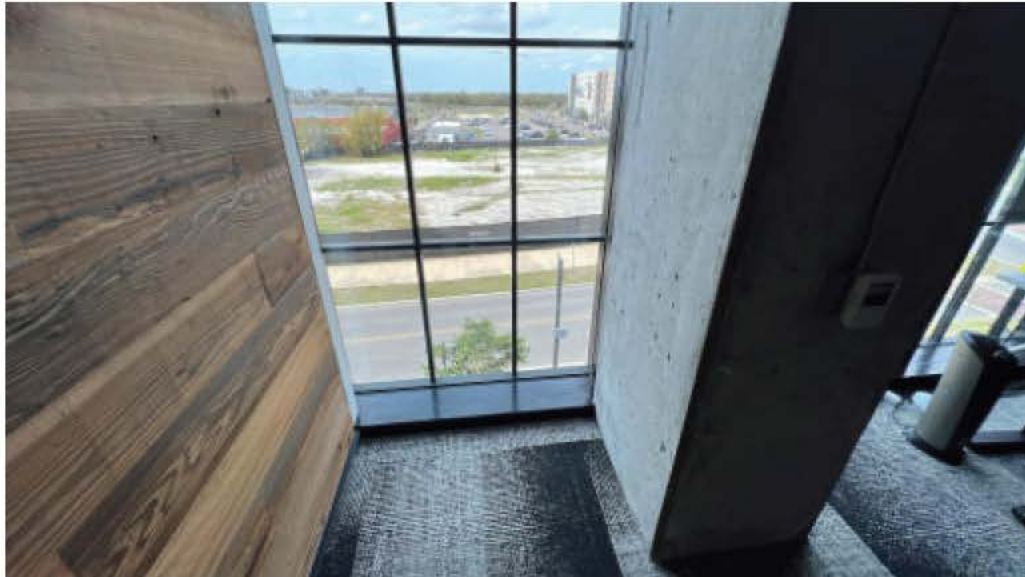
Picture 80: South elevation.
Evidence of water intrusion

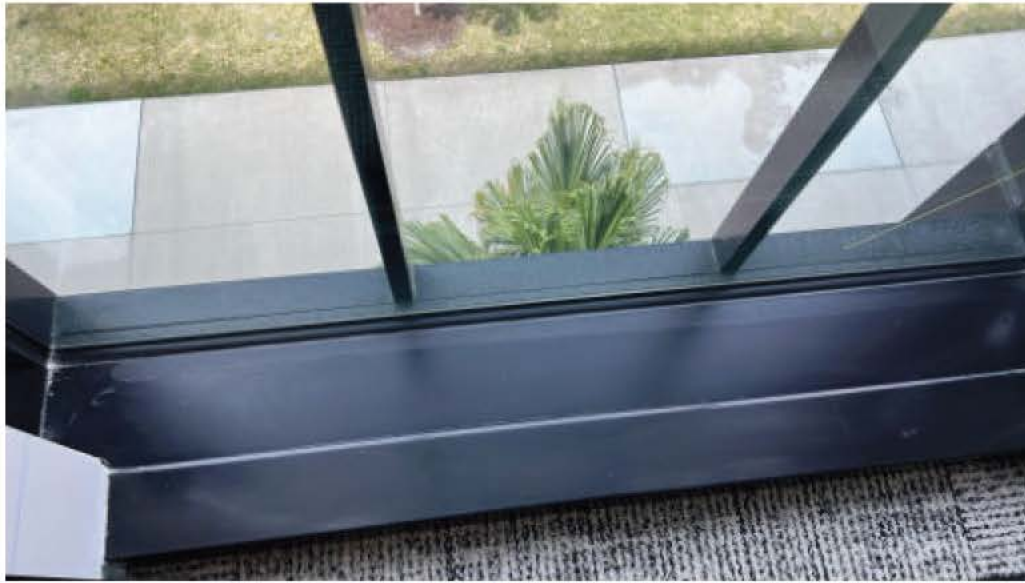
Picture 81: South elevation.
Evidence of water intrusion

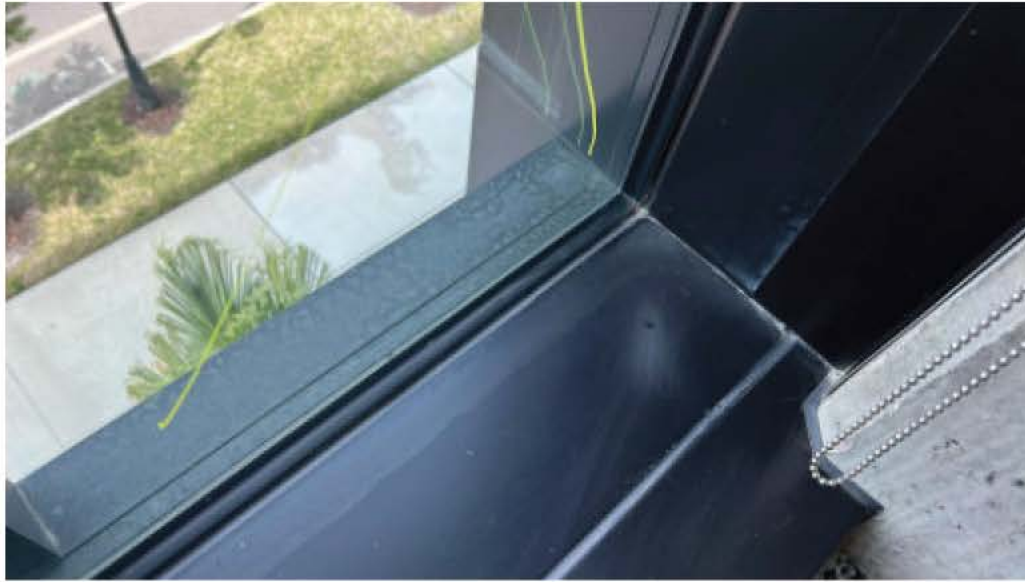
Picture 82: South elevation.
Evidence of water intrusion

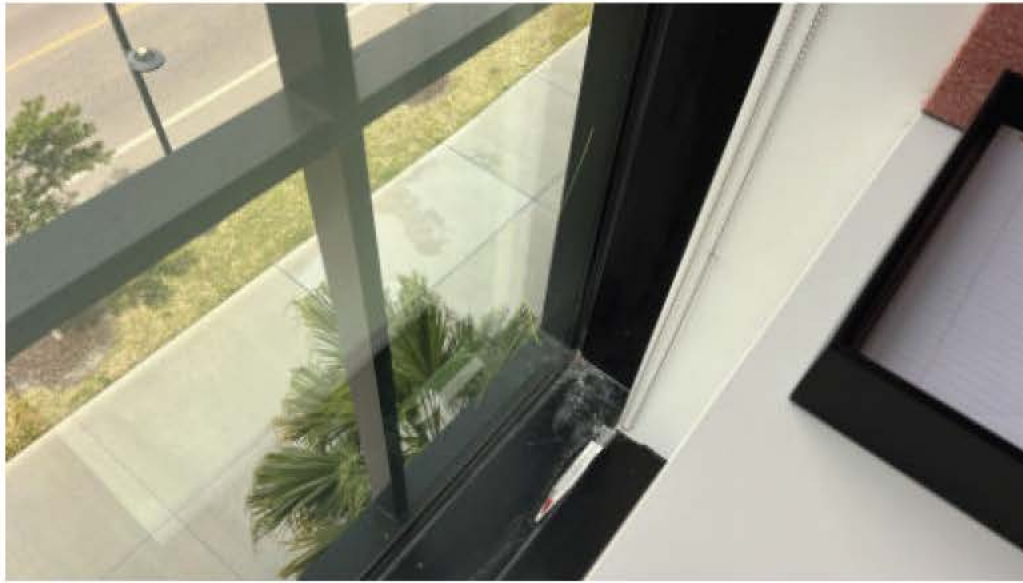
Picture 89: West elevation in conference room. Evidence of water intrusion

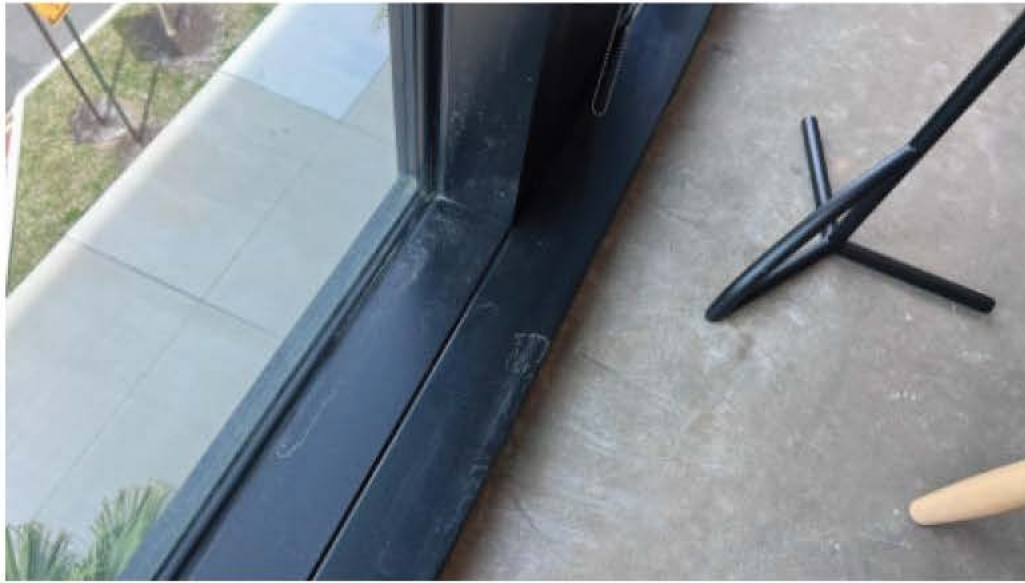
Picture 91: West elevation,
Evidence of water intrusion

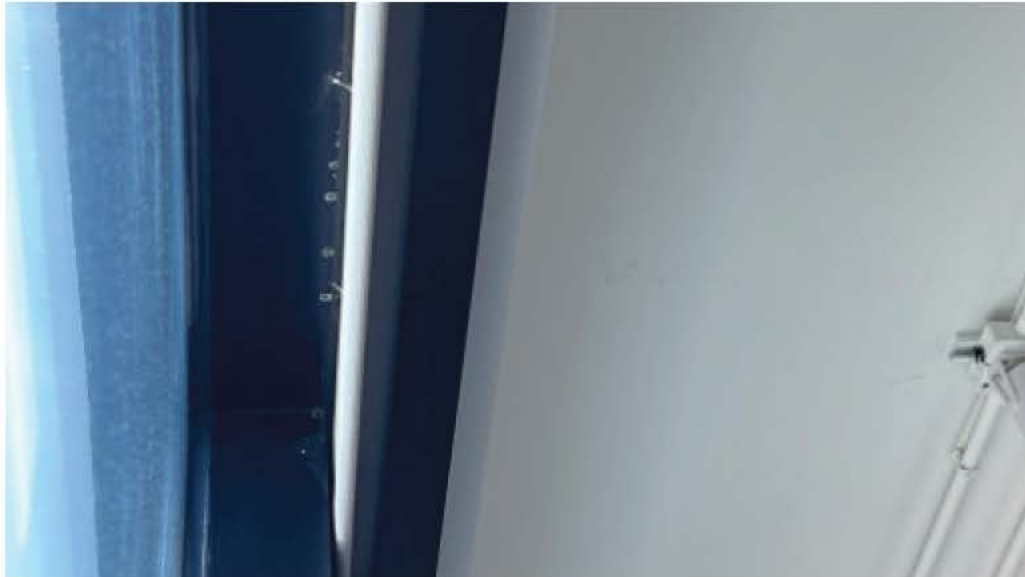
Picture 92: West elevation,
Evidence of water intrusion

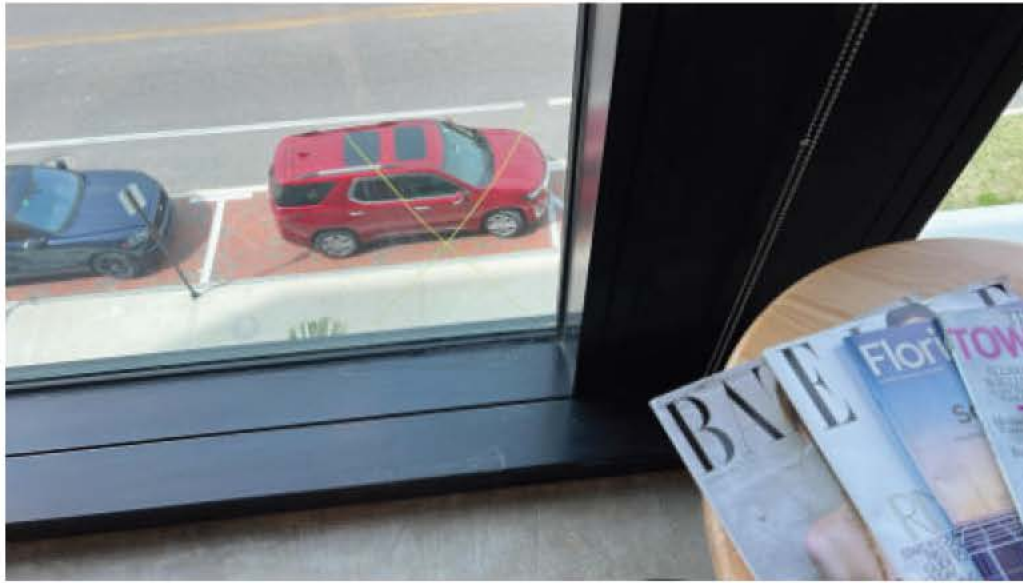
Picture 93: West elevation,
Evidence of water intrusion

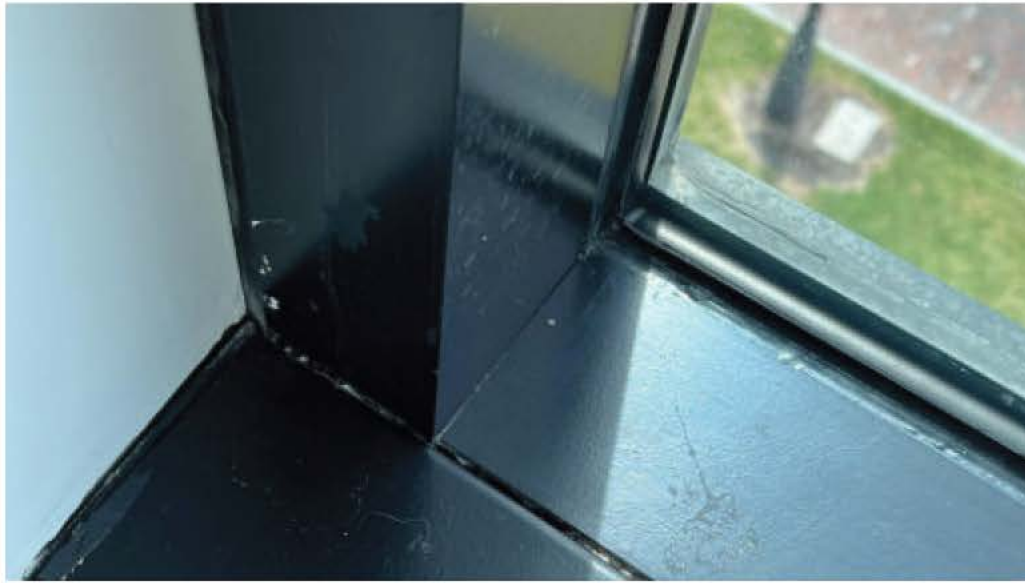
Picture 95: South elevation,
Evidence of water intrusion

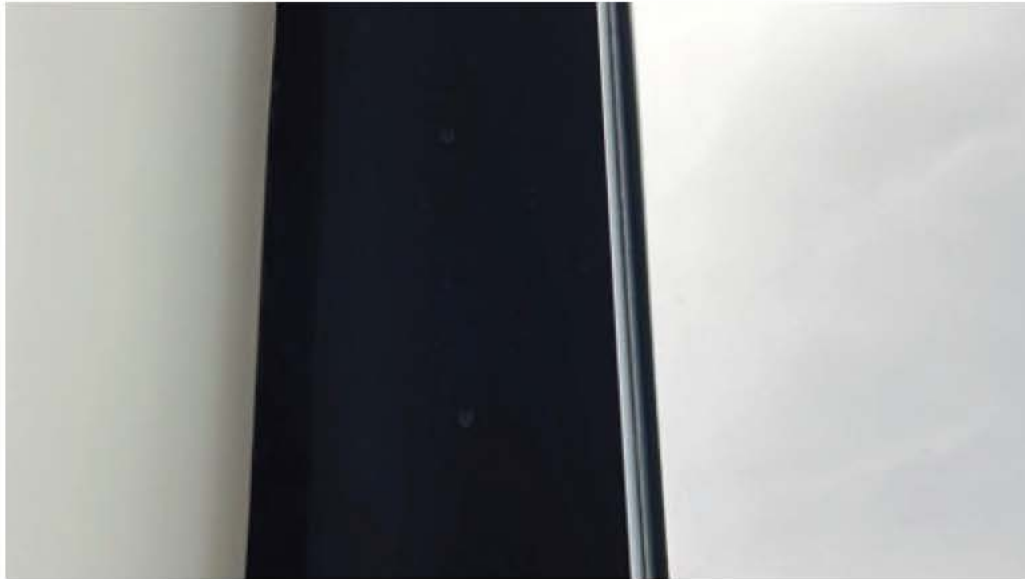
Picture 96: South elevation,
Evidence of water intrusion

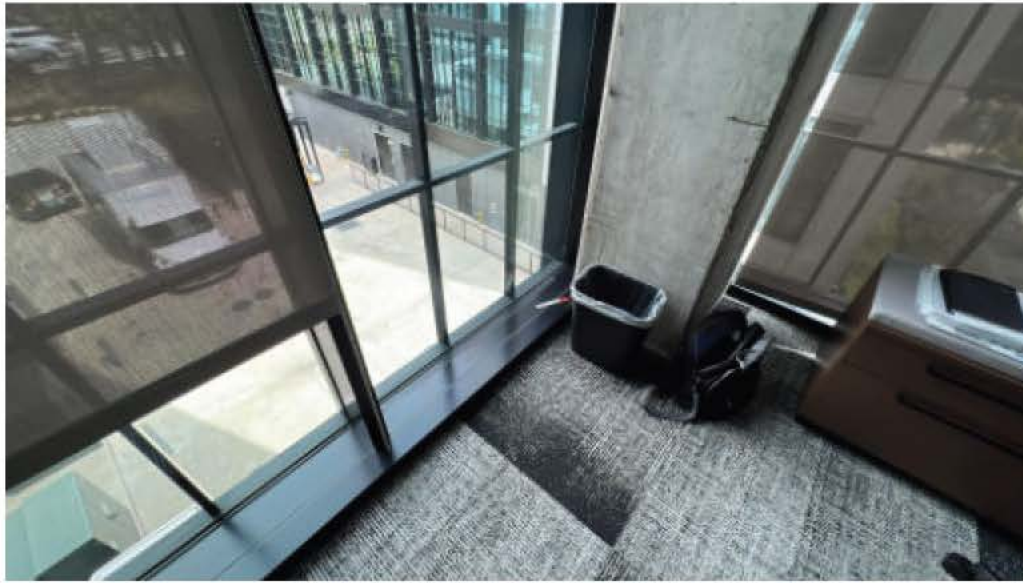
Picture 97: North elevation,
Evidence of water intrusion

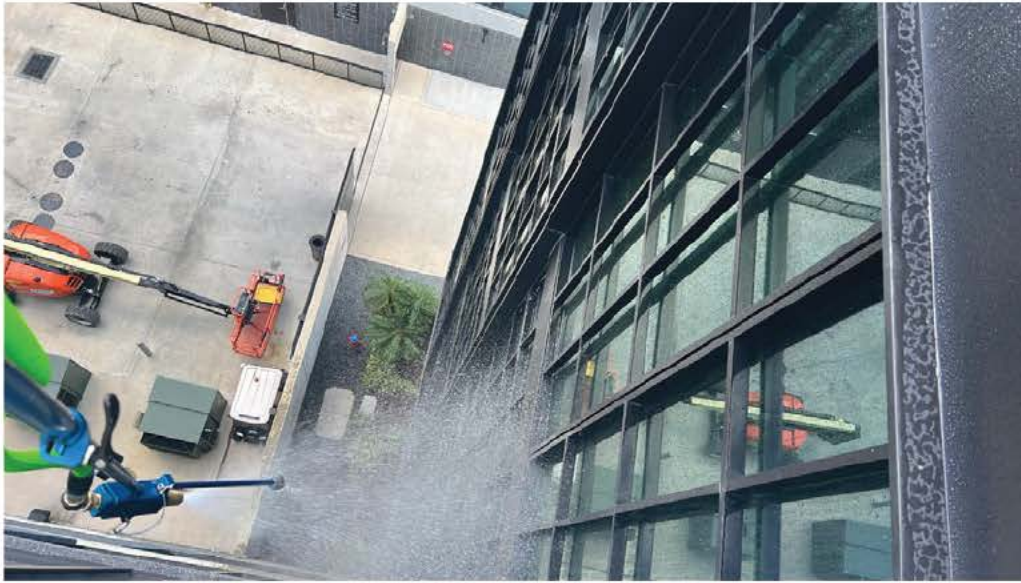
The testing began at the third floor and progressed systematically to the top floor. Water intrusion was not observed until the top of the parapet was tested. An opening in the roof membrane installed over the top of the parapet was discovered, and is likely the source of the water intrusion on the floors below.

Picture 35: Final test-
Sprayed the 6th floor from
the roof, and then the top of
the 6th floor

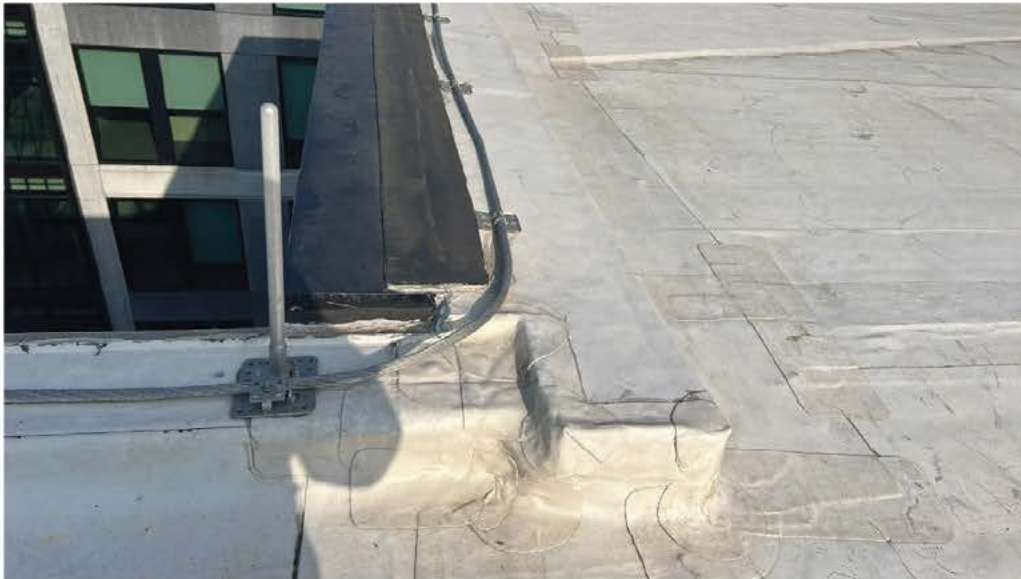
Picture 36: Leak on third
floor is from roof.

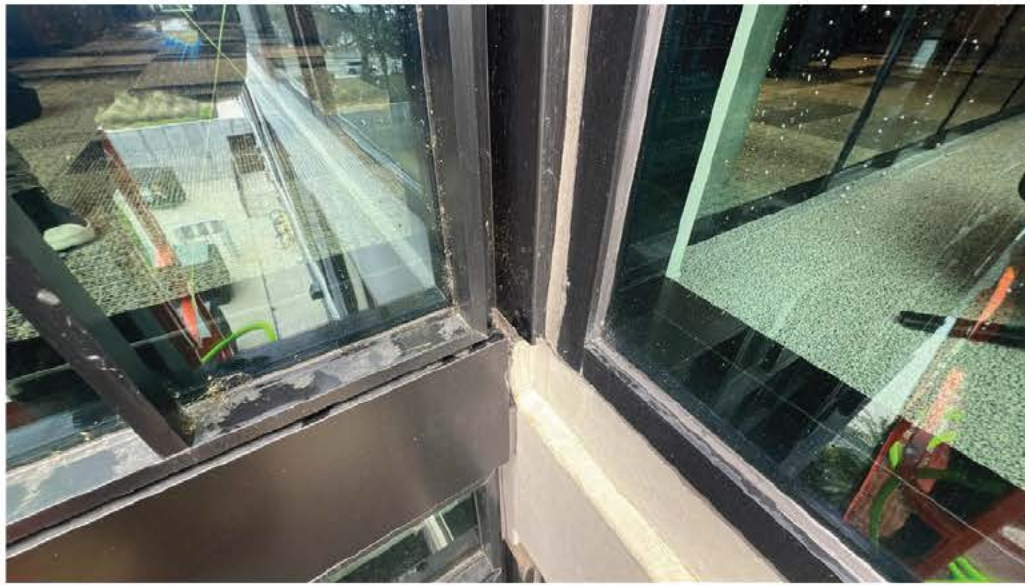
Picture 1: Hole in the sealant at corner

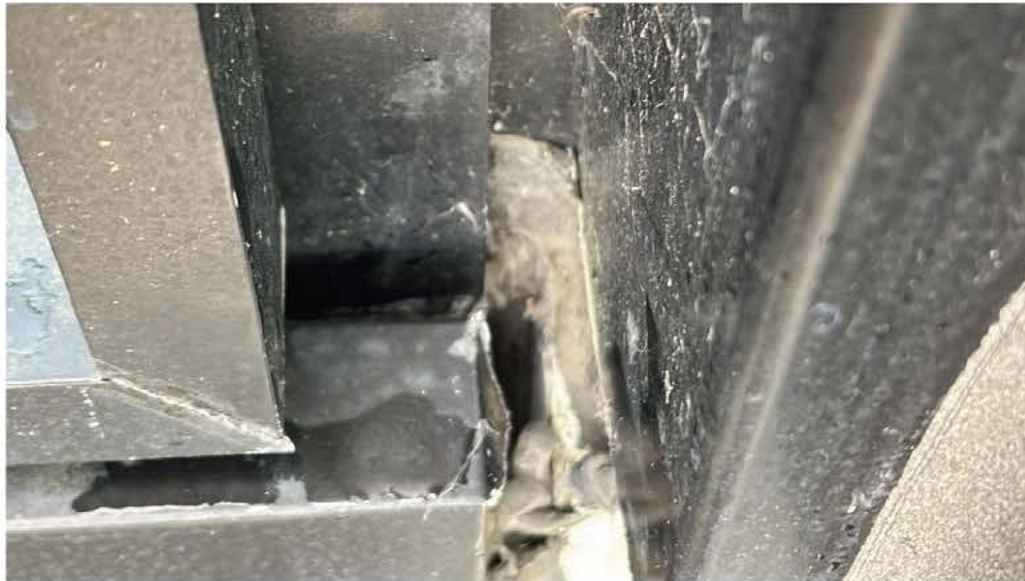
Picture 2: Hole in the sealant at corner

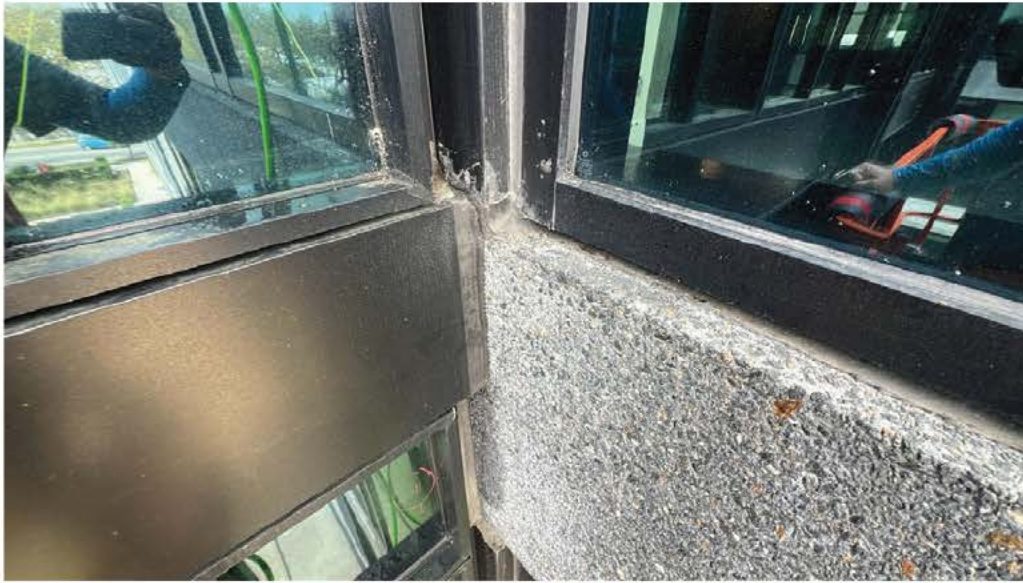
Picture 3: Pre-testing investigation at 4th floor. Sealant has voids and adhesive failure to the stone surface.

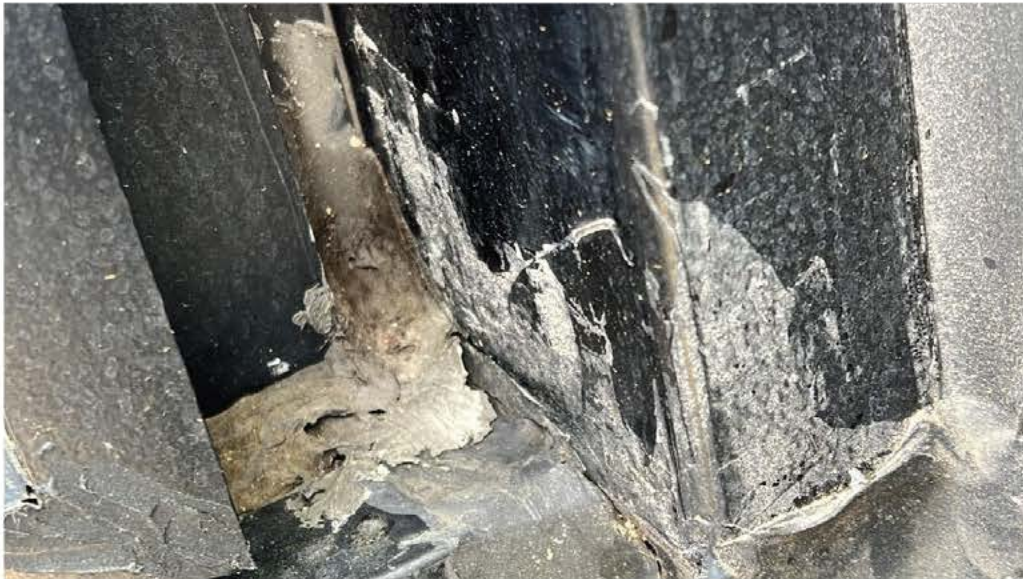
Picture 4: Pre-testing investigation at 4th floor. Sealant has voids and adhesive failure to the stone surface.

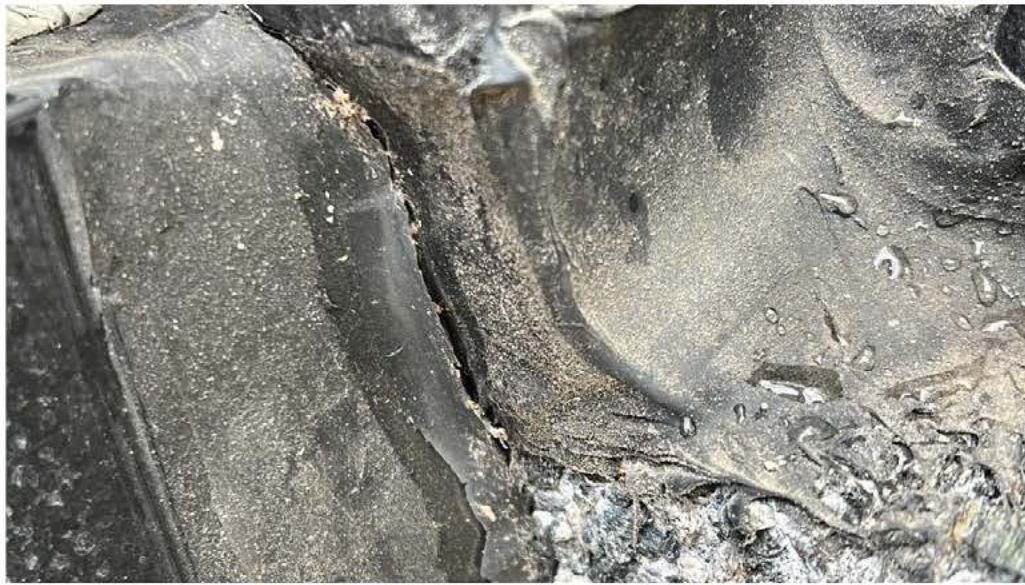
Picture 5: Pre-testing investigation at 4th floor. Sealant has voids and adhesive failure to the stone surface.

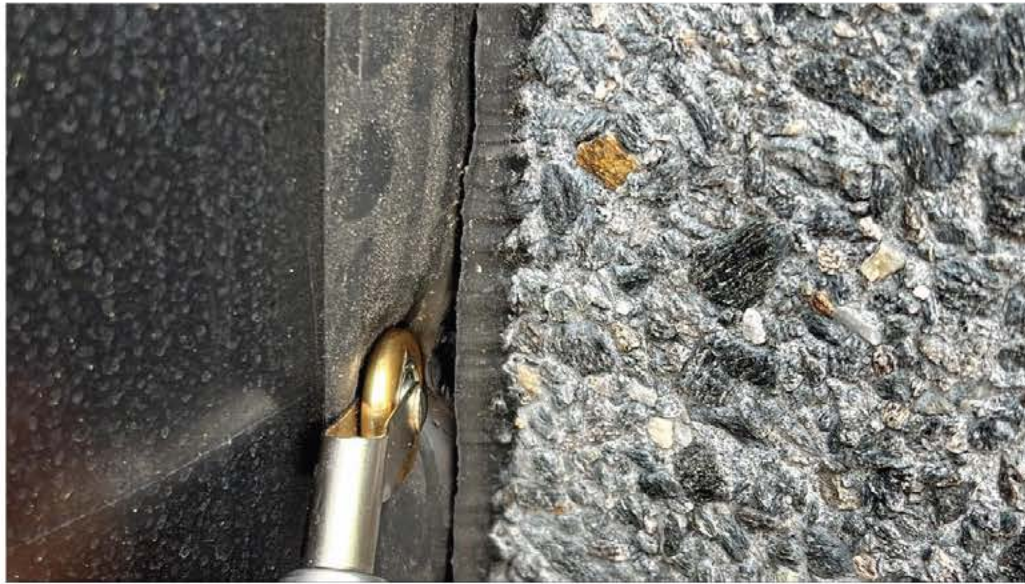
Picture 6: Pre-testing investigation at 4th floor. Sealant has voids and adhesive failure to the stone surface.
