EXTERIOR WALL CONDITION ASSESSMENT REPORT

May 12, 2024

Property: [REDACTED]

Regarding: Exterior Wall Condition Assessment

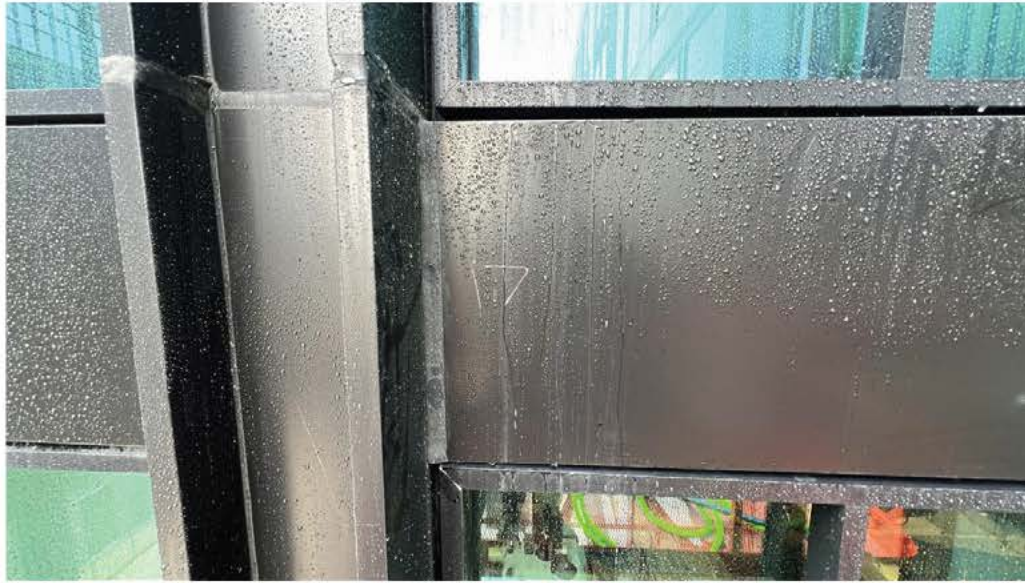
Picture 7: Investigation prior to water testing. Adhesive failure of sealant

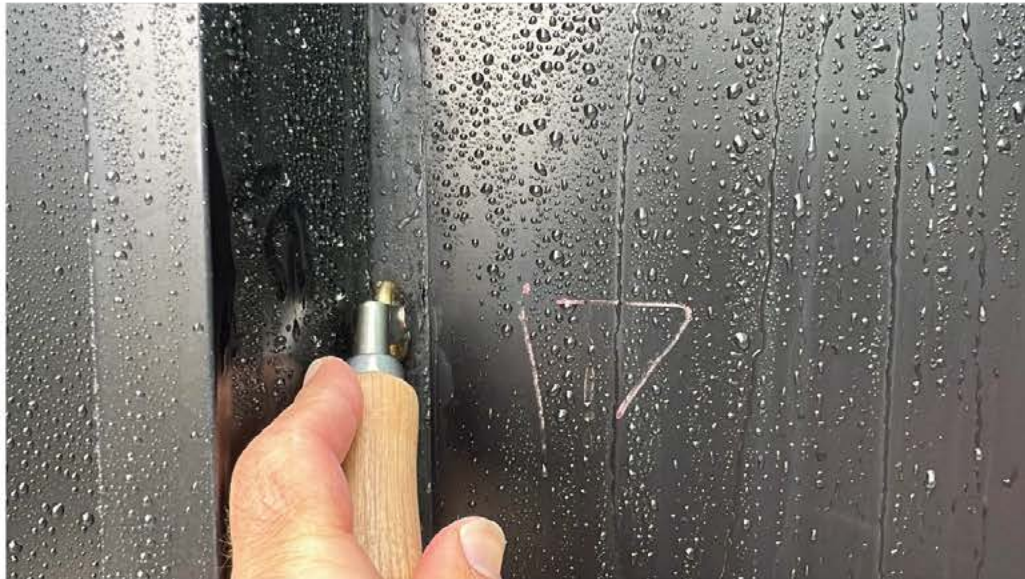
Picture 8: Investigation prior to water testing. Adhesive failure of sealant

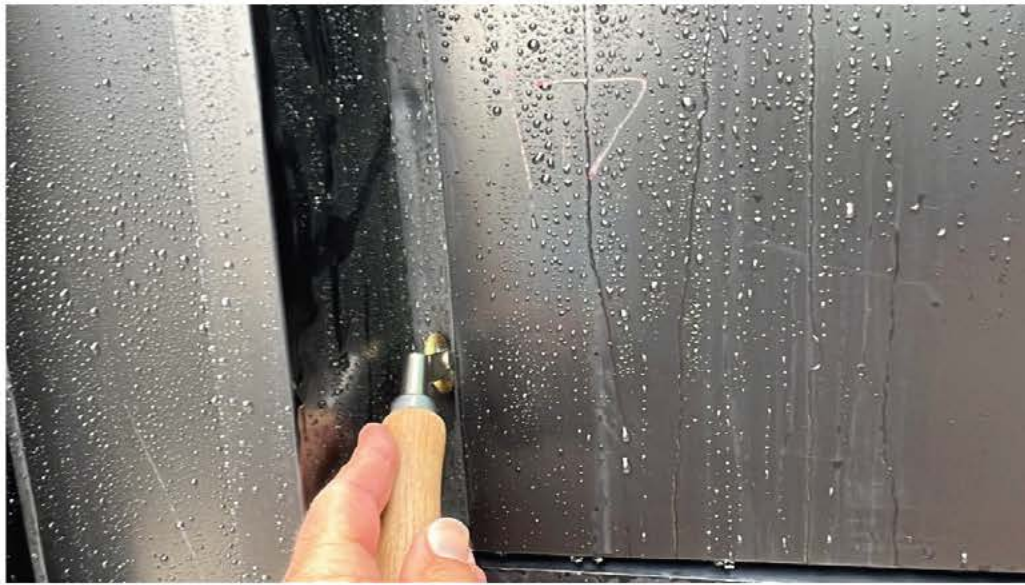
Picture 9: Investigation prior to water testing. Adhesive failure of sealant

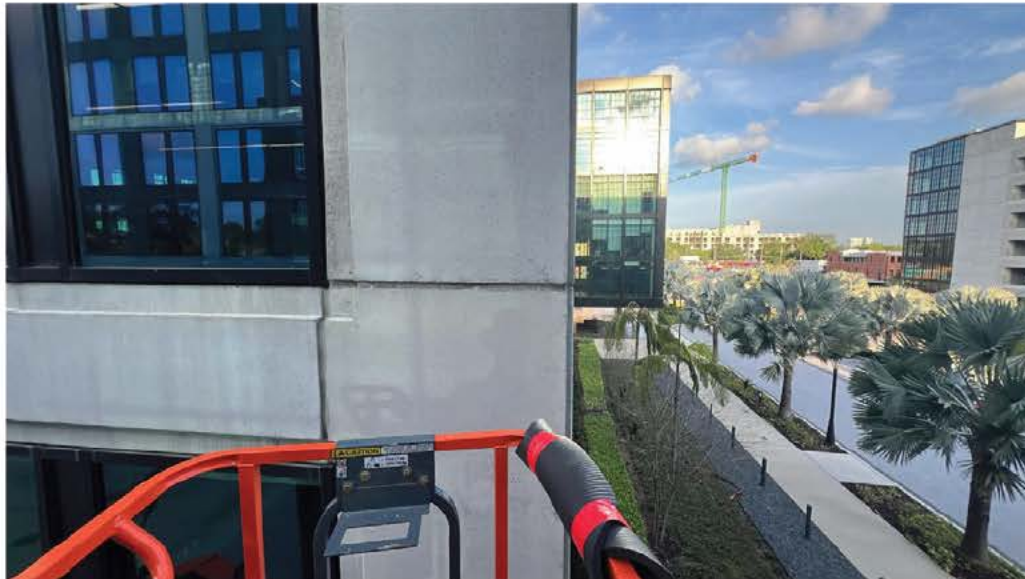
Picture 10: Adhesive failure of the sealant between precast panels.

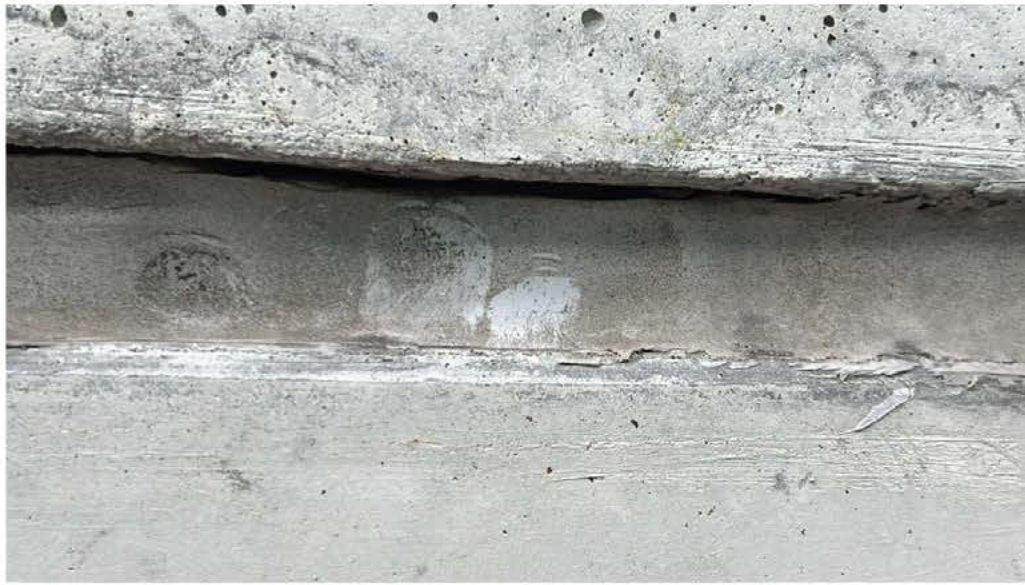
Picture 11: Adhesive failure of the sealant between precast panels.

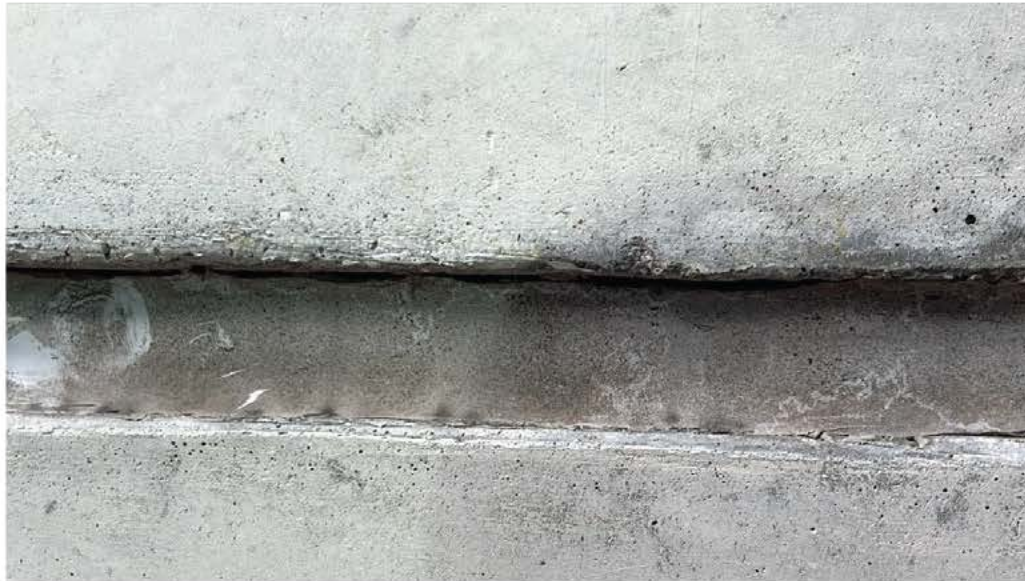
Picture 12: Adhesive failure of the sealant between precast panels.

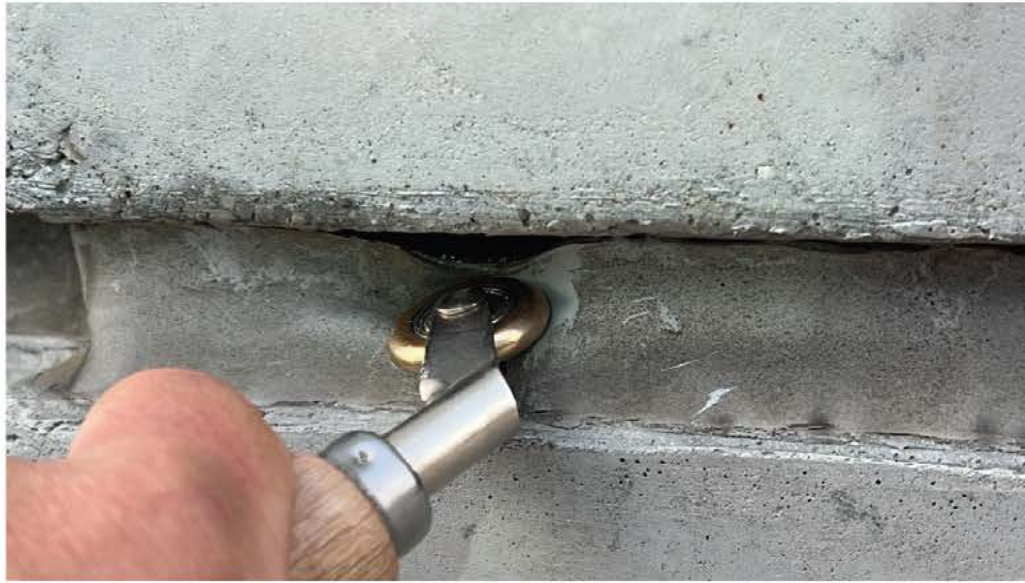
Picture 13: Adhesive failure of the sealant between precast panels.

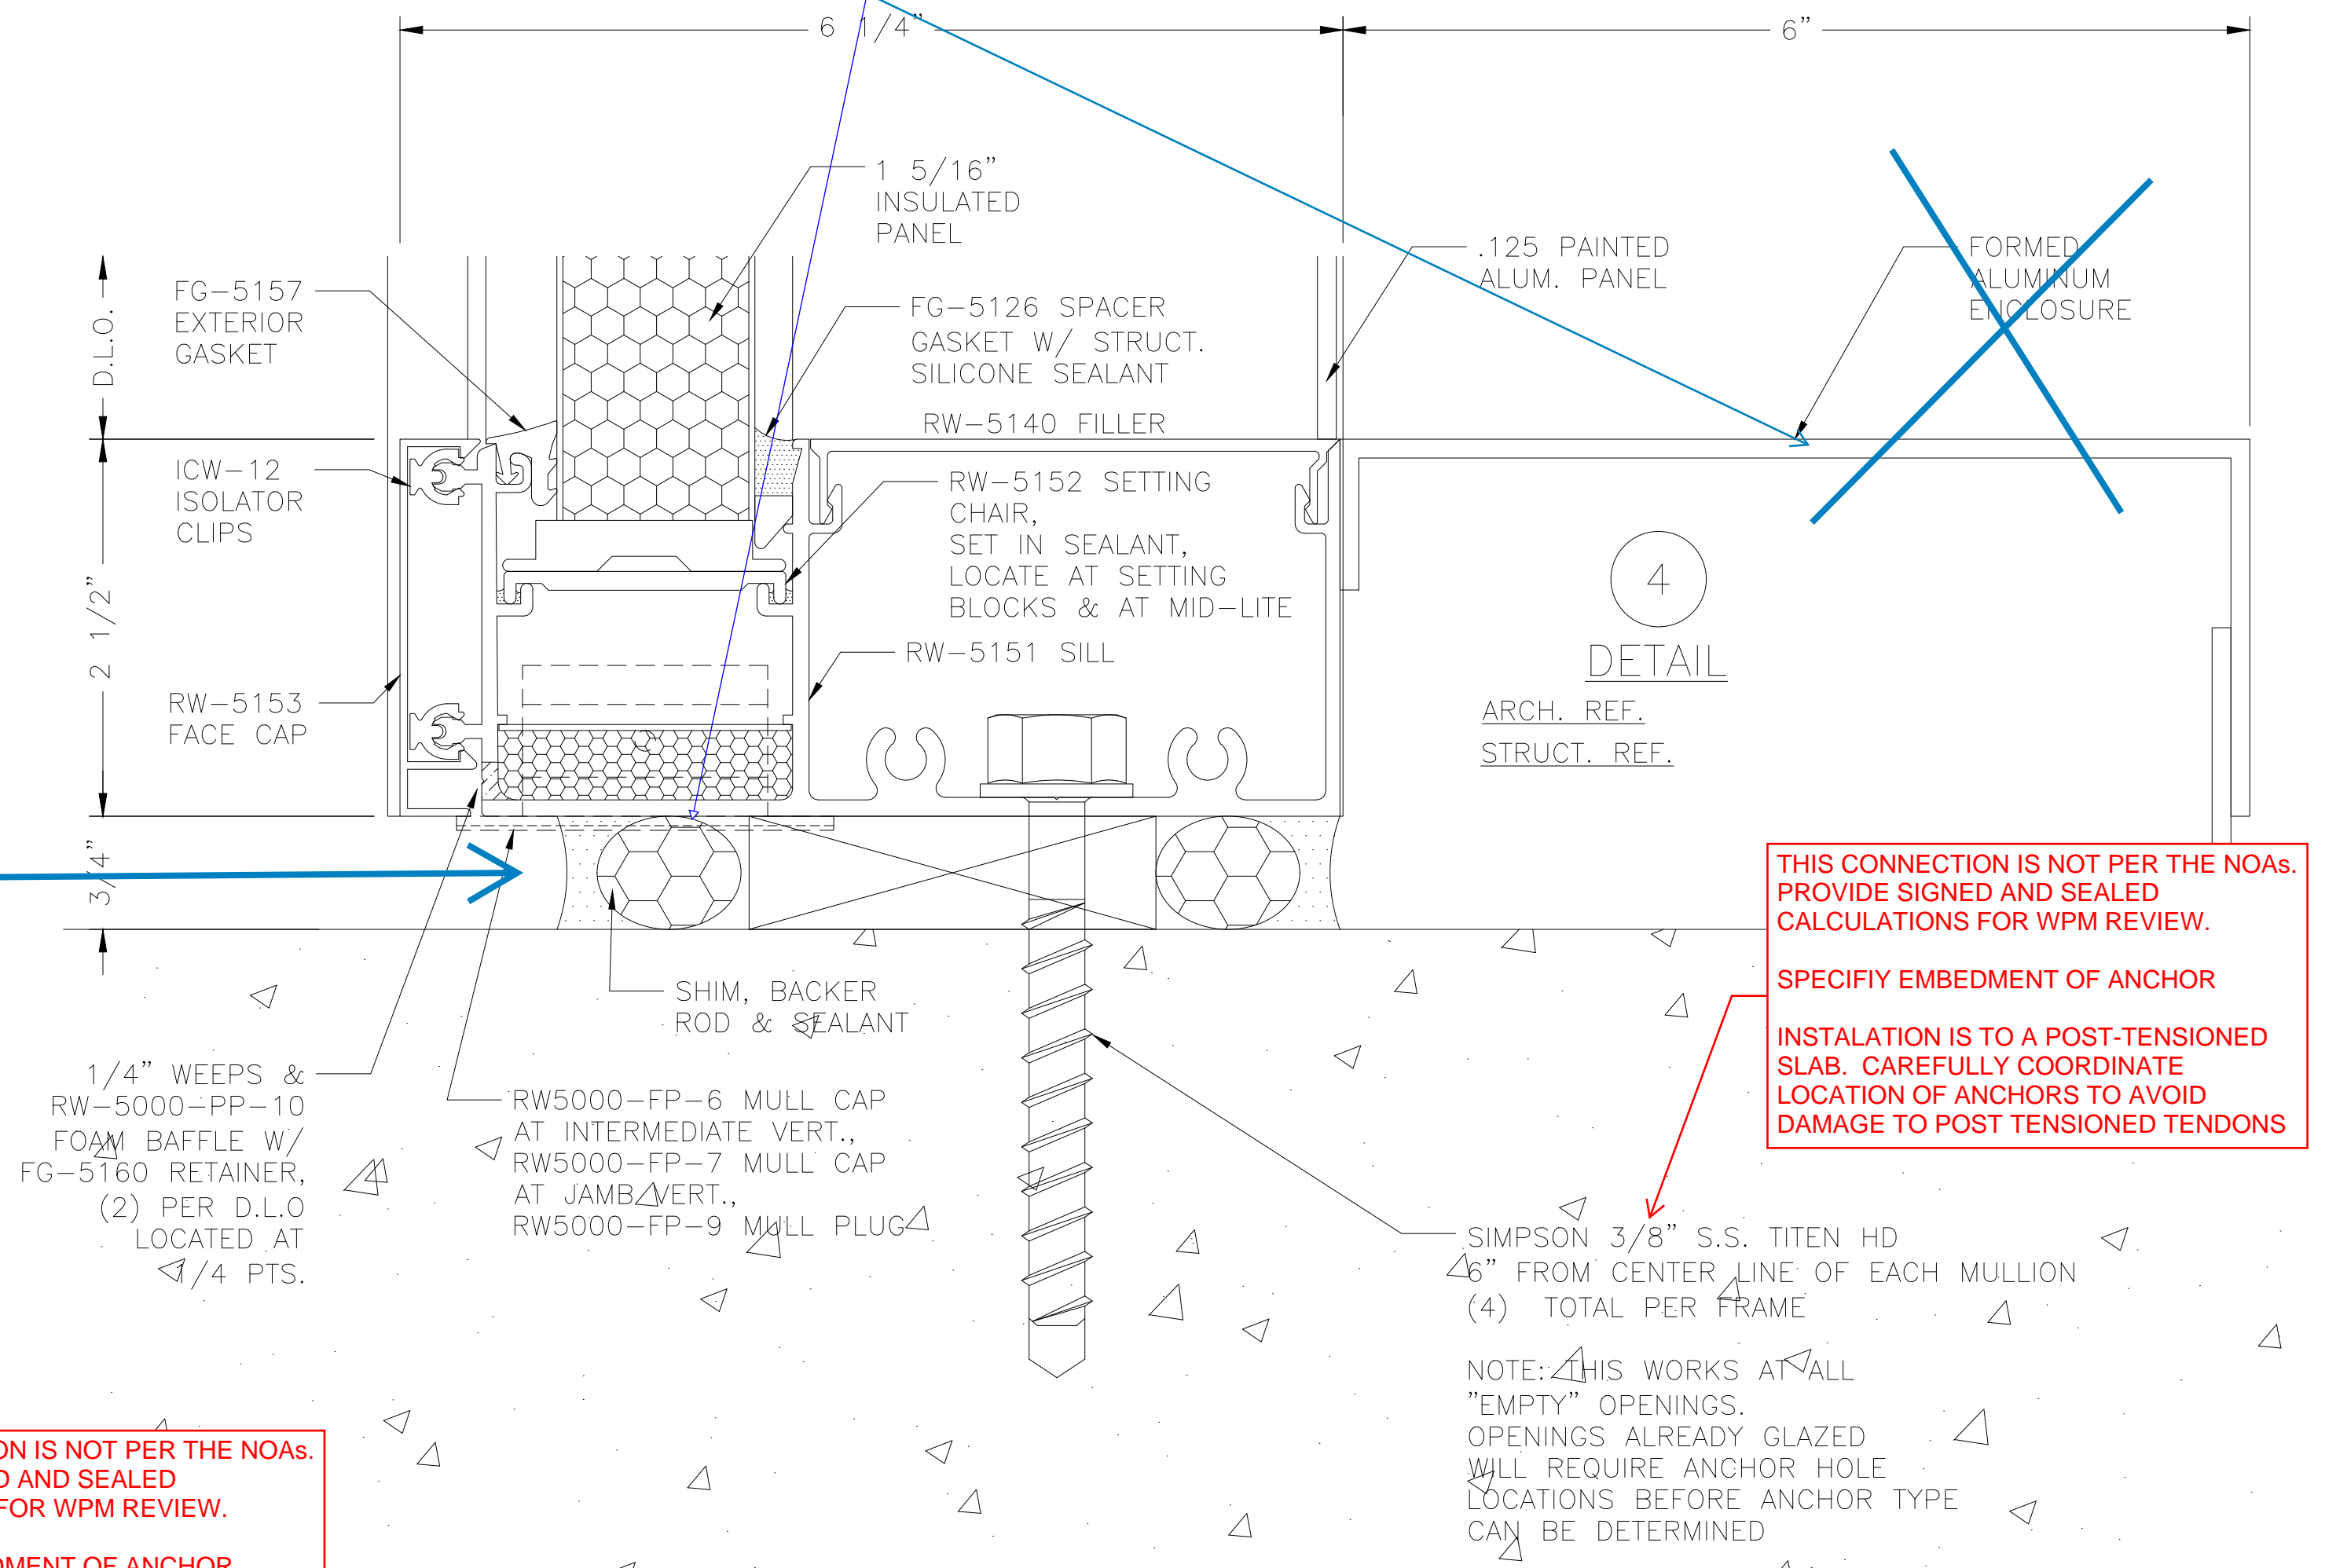
THIS CONNECTION IS NOT PER THE NOAs.
PROVIDE SIGNED AND SEALED
CALCULATIONS FOR WPM REVIEW.

SPECIFY EMBEDMENT OF ANCHOR
