Regarding: Roof Moisture Survey
4.24-XXXX

Dynamic Engineering Design & Inspection (Dynamic) recently performed a Infrared Roof Moisture Survey at Condo at your request for [REDACTED] This report includes the results of our survey.

Exhibit B – Thermograms and Visual Light Images

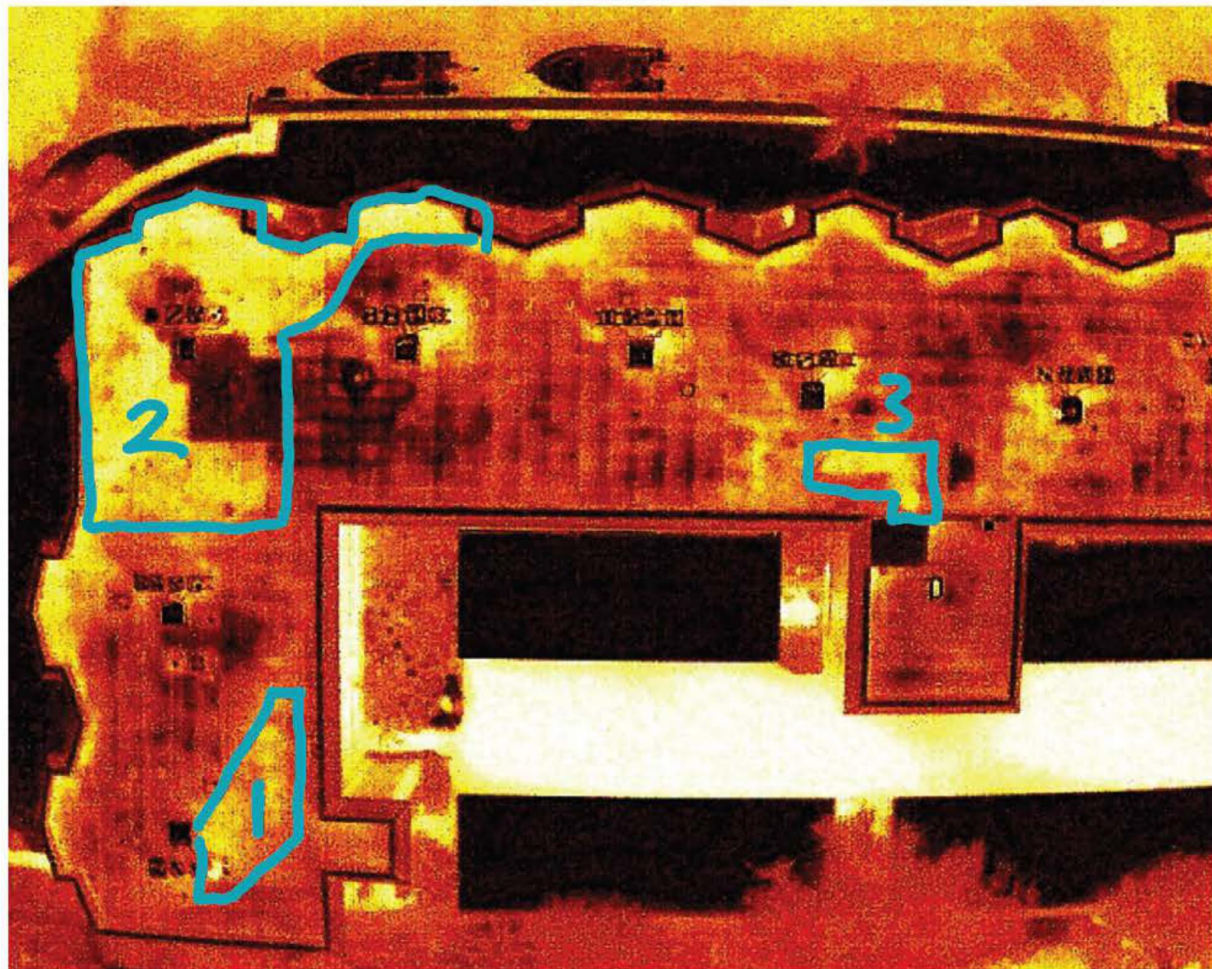
Building	Anomaly	Approx. Area (sf)
A	1	86
A	2	1,560
A	3	86
B	1	1,205
B	1	326
B	2	278
B	3	280
C	1	377
D	1	130

Picture 3: Thermogram of [REDACTED] Thermal anomalies consistent with wet insulation outlined in blue.
1: Approximately 86 sf.
2: Approximately 1,560 sf.
3: Approximately 86 sf.

1. remove the existing roof covering entirely, or only at areas with wet LWIC
2. replace all damaged LWIC
3. remediate (dry or replace) all wet LWIC
4. Install a new roof covering with an applicable Florida Product Approval, complete with flashings.

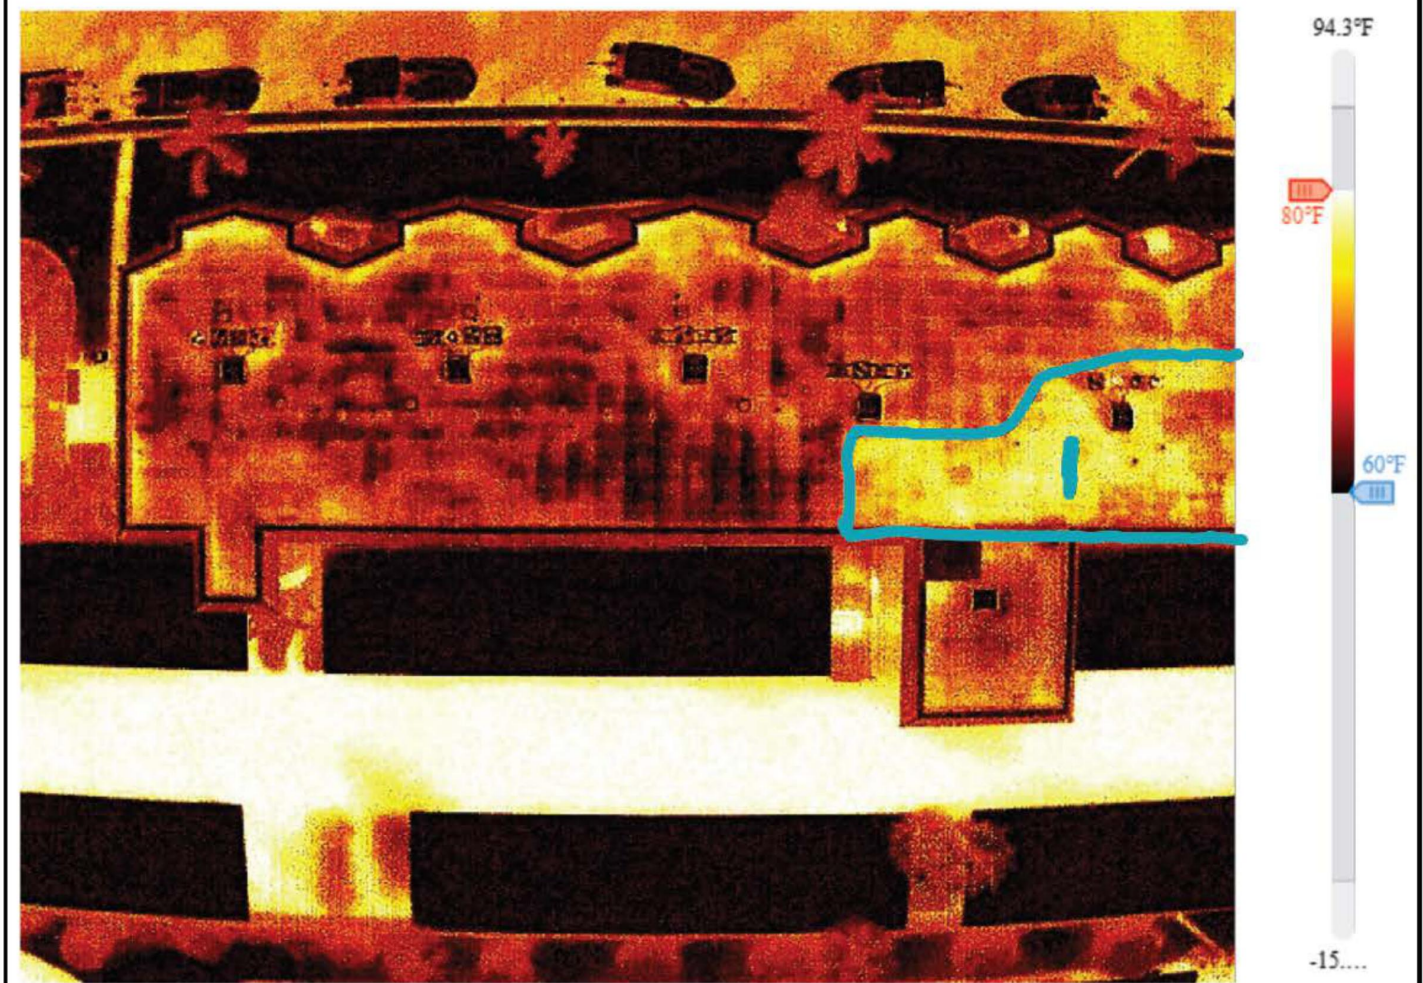
Picture 6: Thermogram of The [REDACTED] Thermal anomalies consistent with wet insulation outlined in blue.

1: Approximately 1,205 sf.

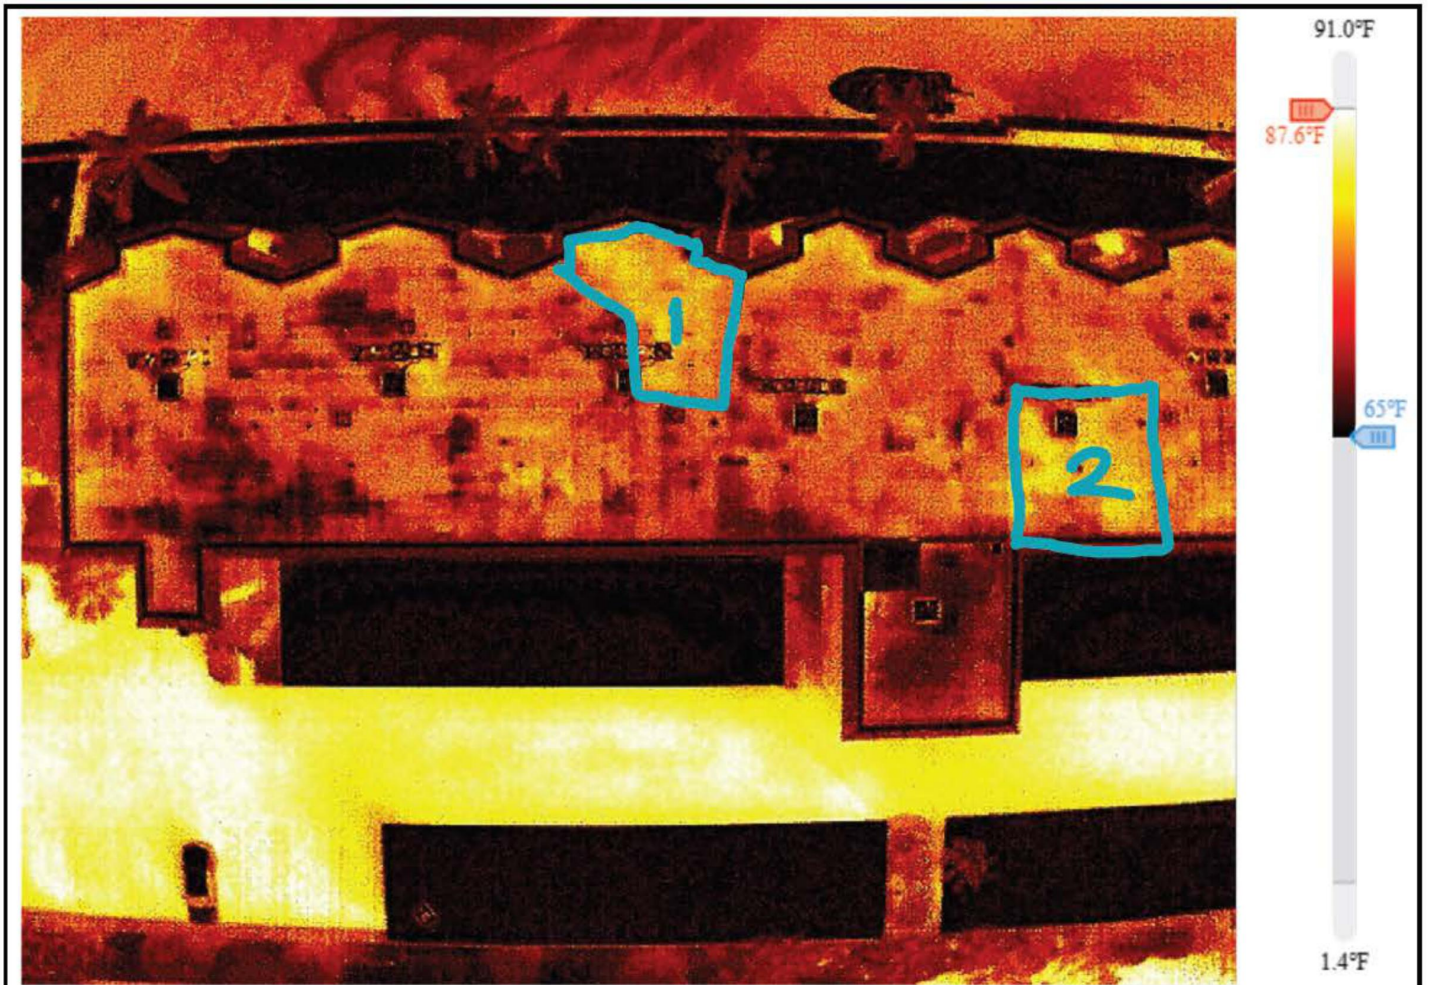
Picture 9: Thermogram of [REDACTED] Thermal anomalies consistent with wet insulation outlined in blue.

1: Approximately 326 sf.

2: Approximately 278 sf.

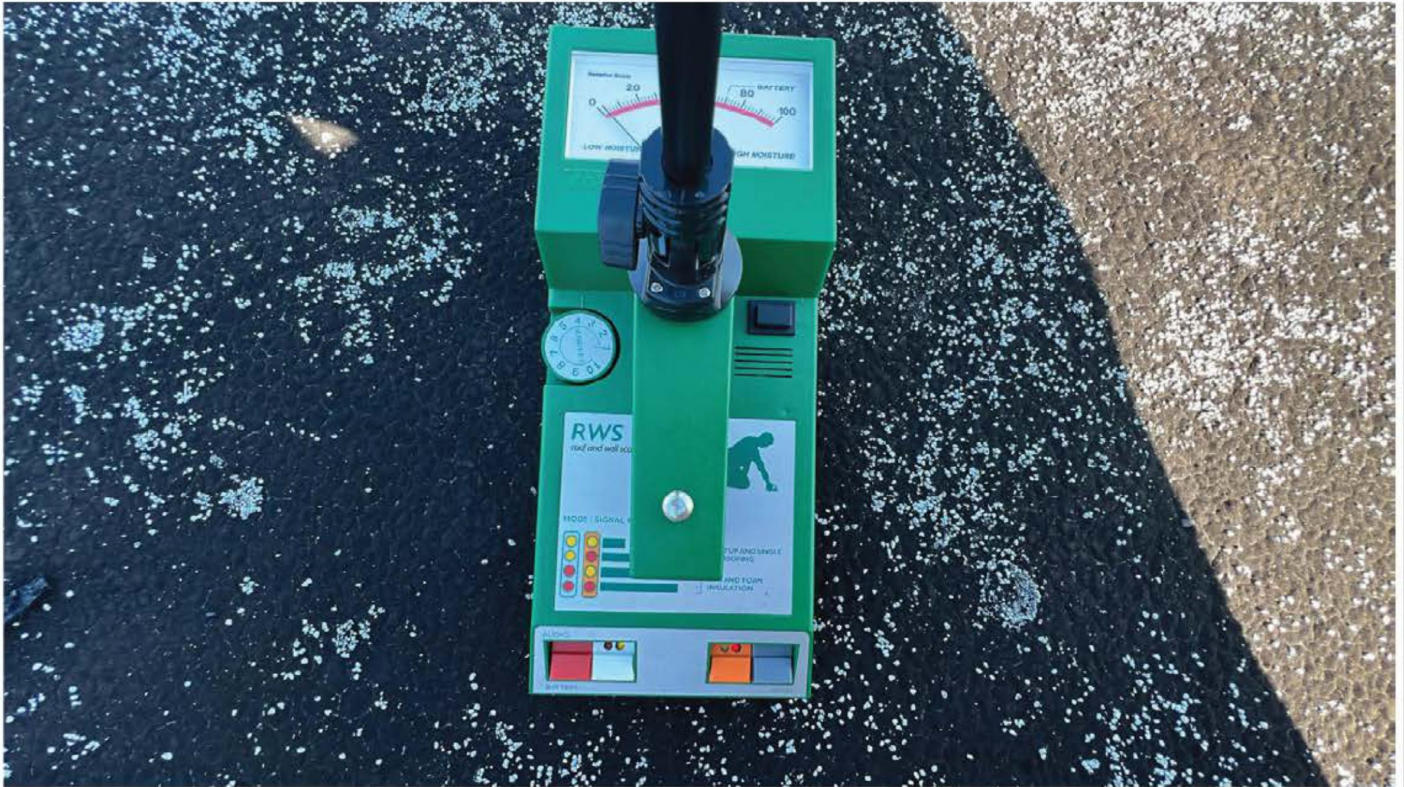
Picture 19: Dry insulation corroboration on The [REDACTED]

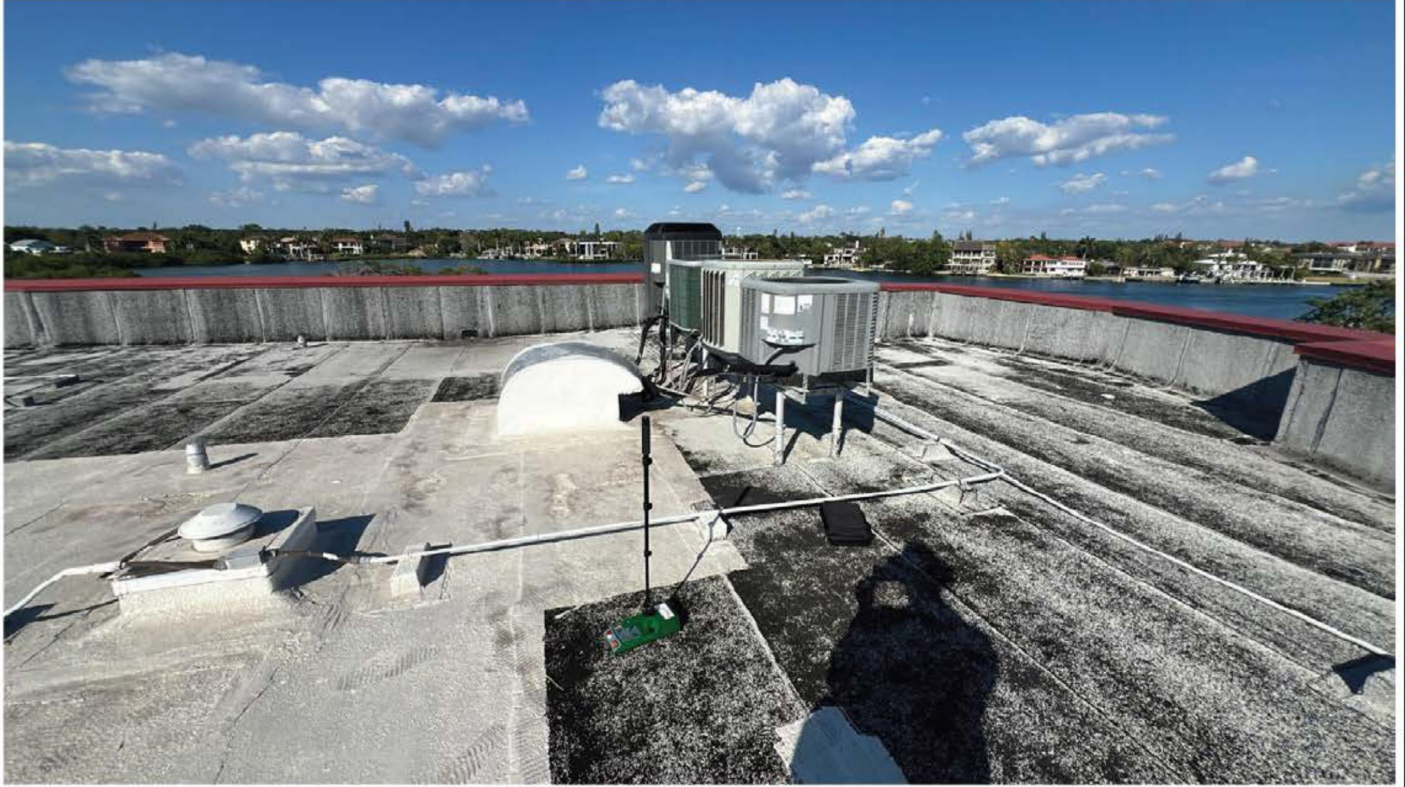
Picture 20: Wet insulation corroboration on The [REDACTED]
