# ROOF REPORT

Carport Roof Condition Assessment

**Regarding:** Limited Carport Roof Condition Assessment

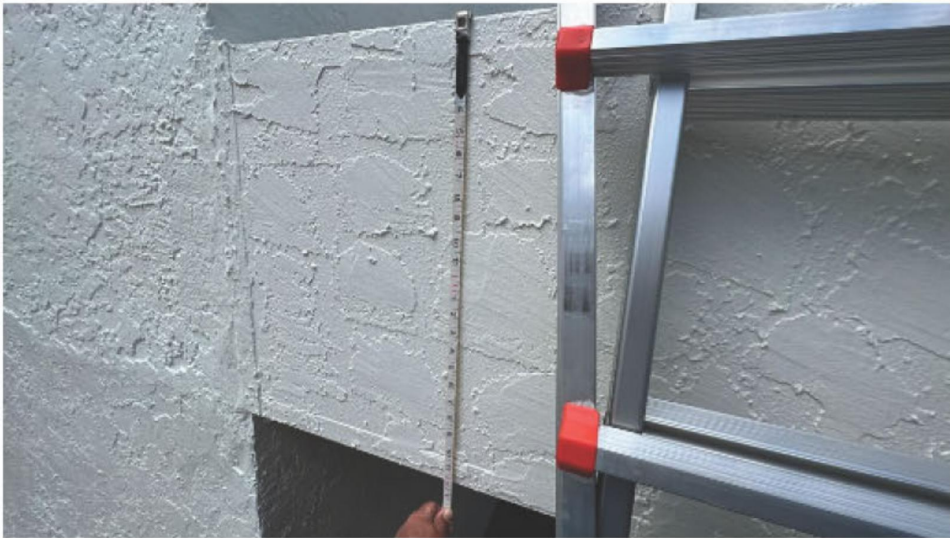
<p>Picture 6: perimeter panels are 2' high</p> <p>Lat: 26.25343</p> <p>Long: -81.81120</p> <p>Bearing: NW</p> <p>Date Taken: 10/05/2023</p> <p>Weather: Partly cloudy</p> <p>Taken By: Matthew Mullins</p> <p>Tags: A-661</p>
---	---

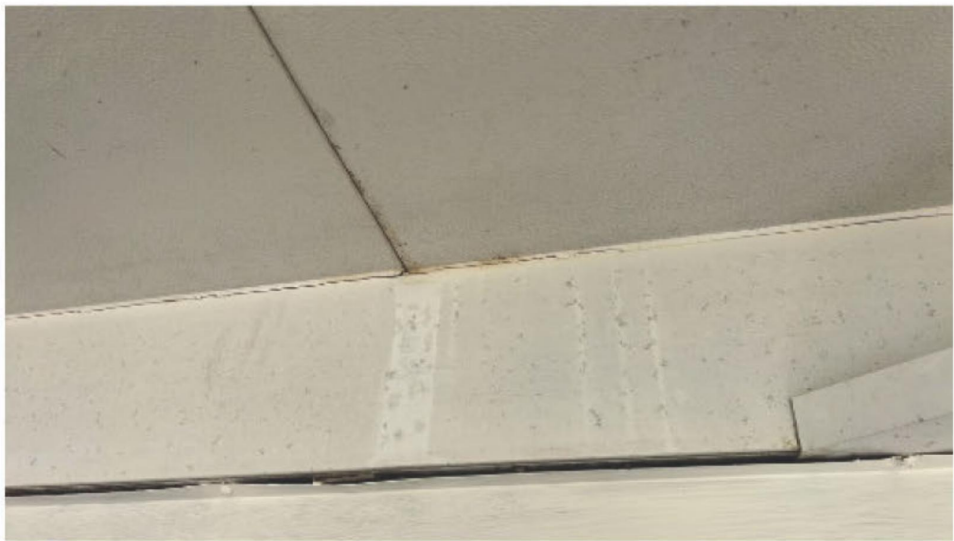
Picture 7: signs of water intrusion through the panels.
	Lat: 26.25350 Long: -81.81114 Bearing: NE Date Taken: 10/05/2023 Weather: Partly cloudy Taken By: Matthew Mullins Tags: A-661

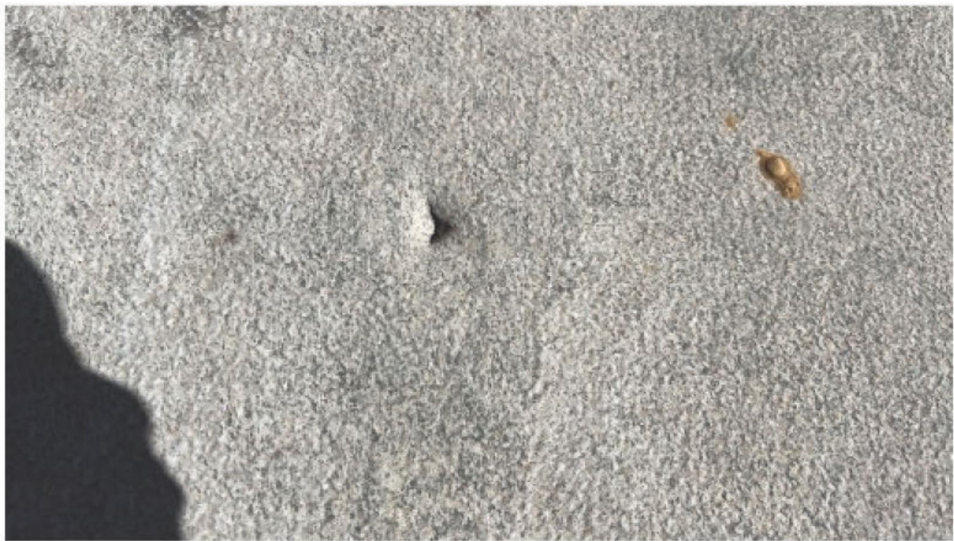
Picture 179: puncture
	Lat: 26.25396 Long: -81.81591 Bearing: SE Date Taken: 10/05/2023 Weather: Patchy rain possible Taken By: Matthew Mullins Tags: P-589

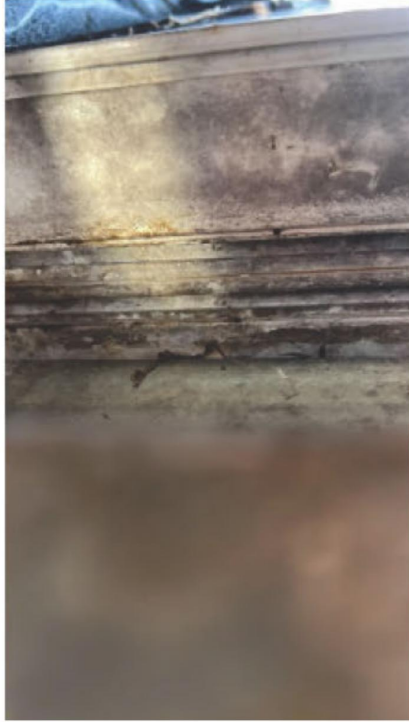
Picture 187: view through gutter outlet- (2) 2x7 aluminum beams

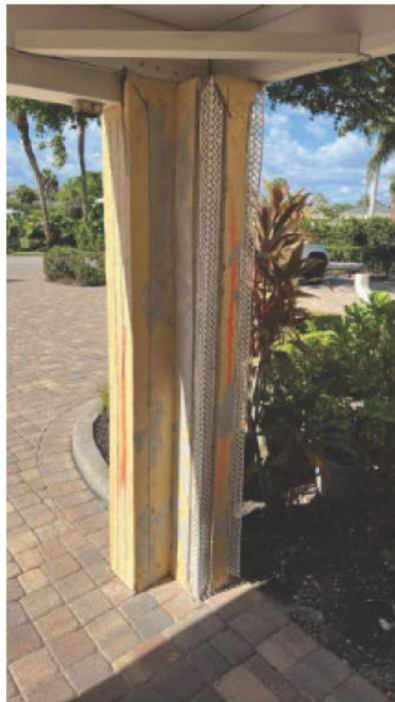
Picture 188: stucco corner bead replacement in progress
