FIELD OBSERVATION REPORT

PROJECT	
PROPERTY	[REDACTED]
PROJECT	Concrete Restoration Project
ADDRESS	[REDACTED] Venice, FL 34285

Dynamic arrived on site to observe the progress of the concrete repair project. The building be reviewed is 226,225,125,126

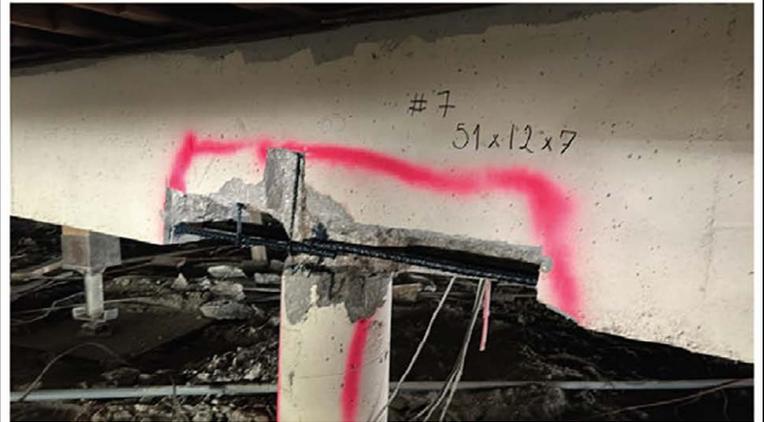
Media 20: P124 used here

Some rebar was coated with P124 and some were coated with EpoCem. Contractor mentioned they were re-coating the rebar with P124 with EpoCem.

VARIANCE LOG		
DESCRIPTION	DATE REPORTED	RESOLVED
Sika 211 needs EOR approval for application	07/19/2024	
Beam Detail dimension to be reviewed by EOR. Dimensions don't match existing conditions.	07/19/2024	
Column Detail dimension to be reviewed by EOR. Dimensions don't match existing conditions	07/19/2024	
Switch from P124 to EpoCem to be confirmed by EOR	07/19/2024

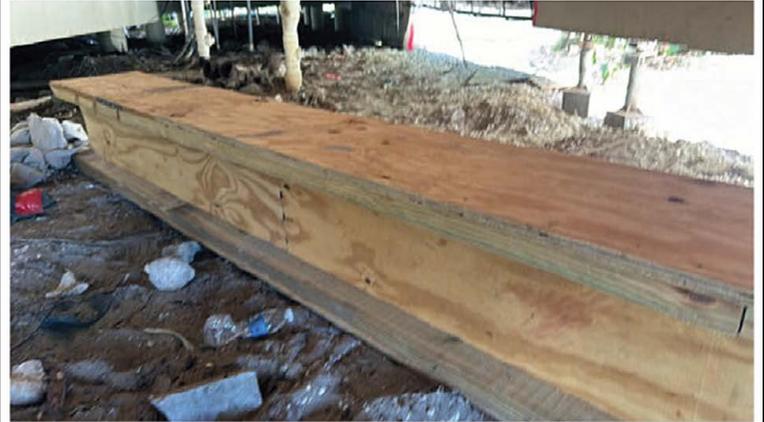
Media 46: Forms for Location 19

Forms were observed to be in the process of installation.
