EXTERIOR WALL CONDITION ASSESSMENT REPORT

May 12, 2024

Property: [REDACTED]

Regarding: Exterior Wall Condition Assessment

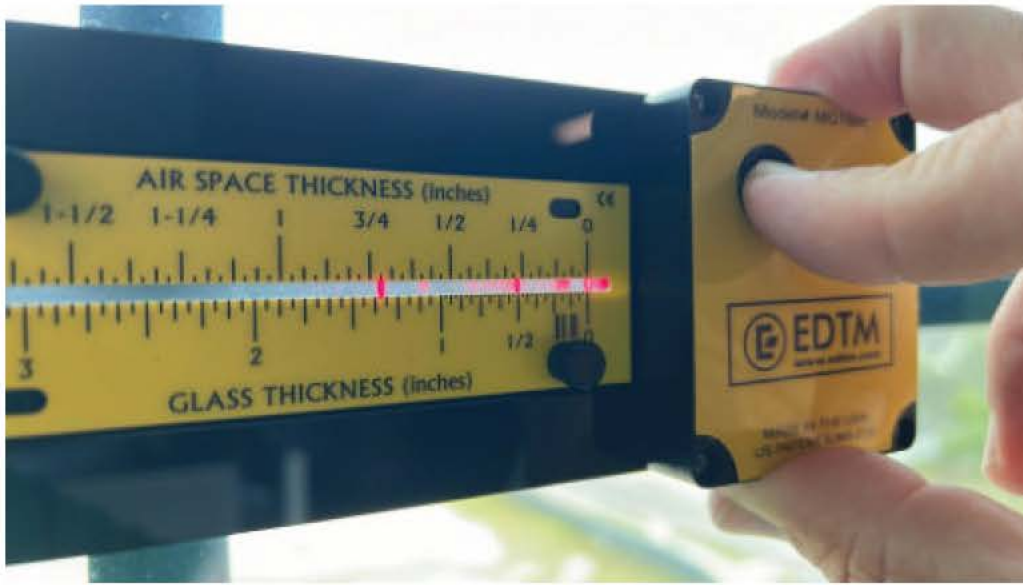
Picture 1: Laminated and insulated glass

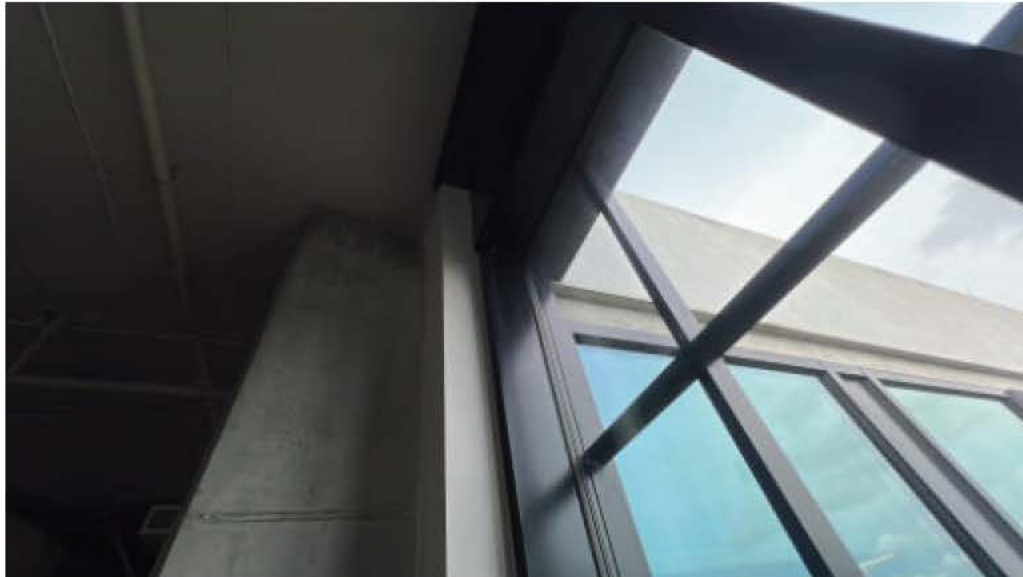
Picture 2: Outside 622/625. Evidence of water intrusion

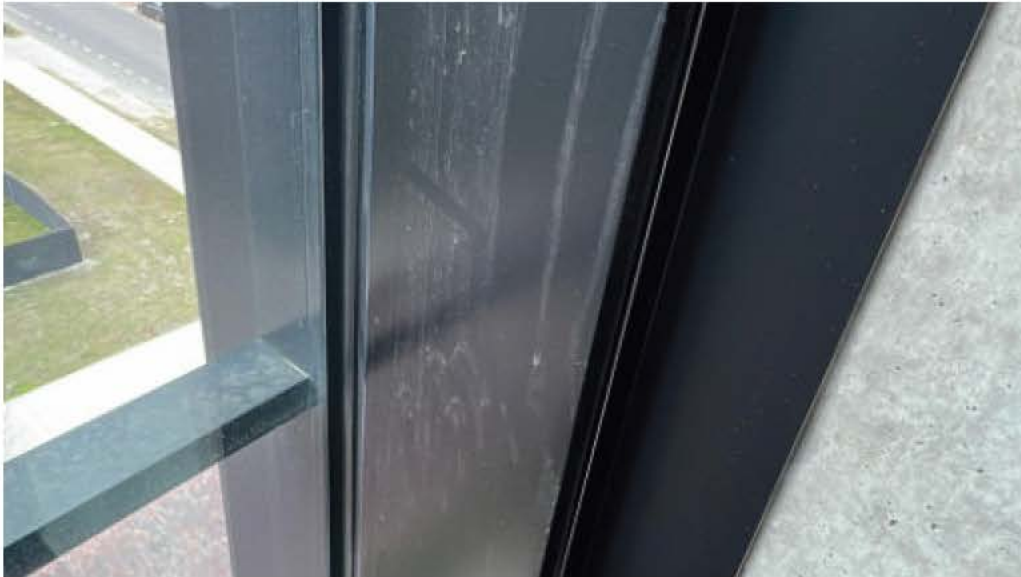
Picture 24: Common area, south elevation. Evidence of water intrusion

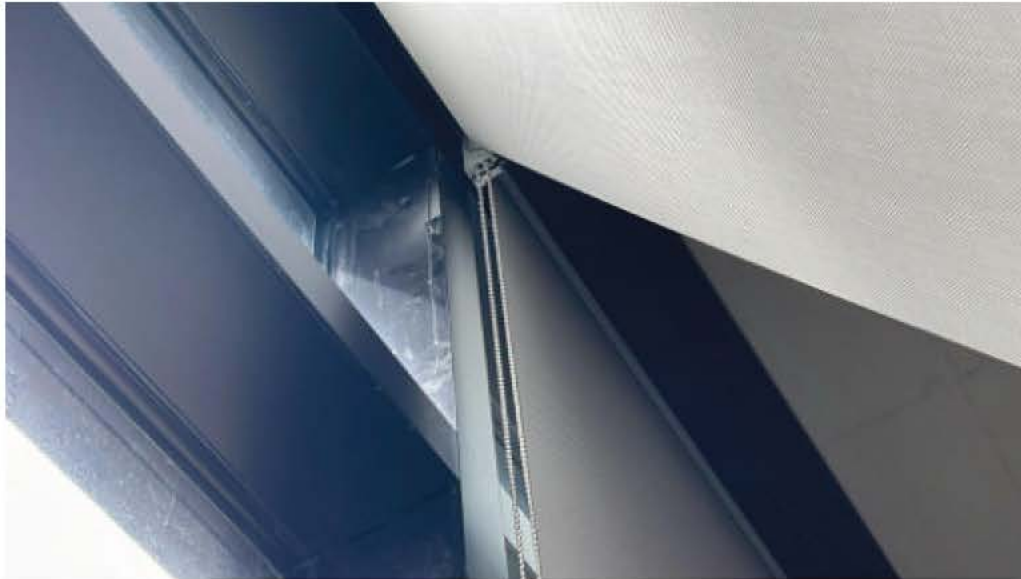
Picture 30: Common area, south elevation. Evidence of water intrusion

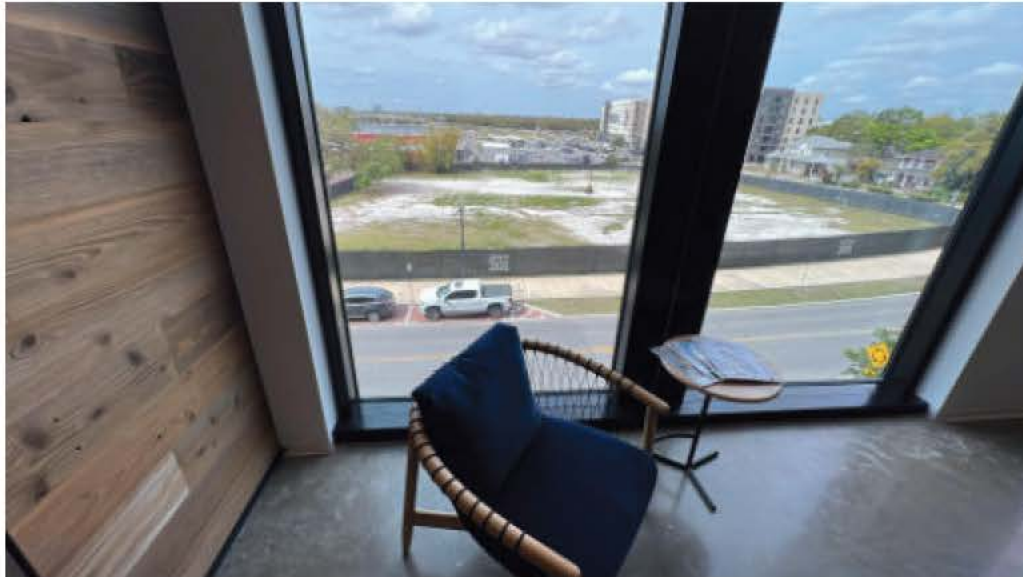
Picture 90: West elevation, Evidence of water intrusion

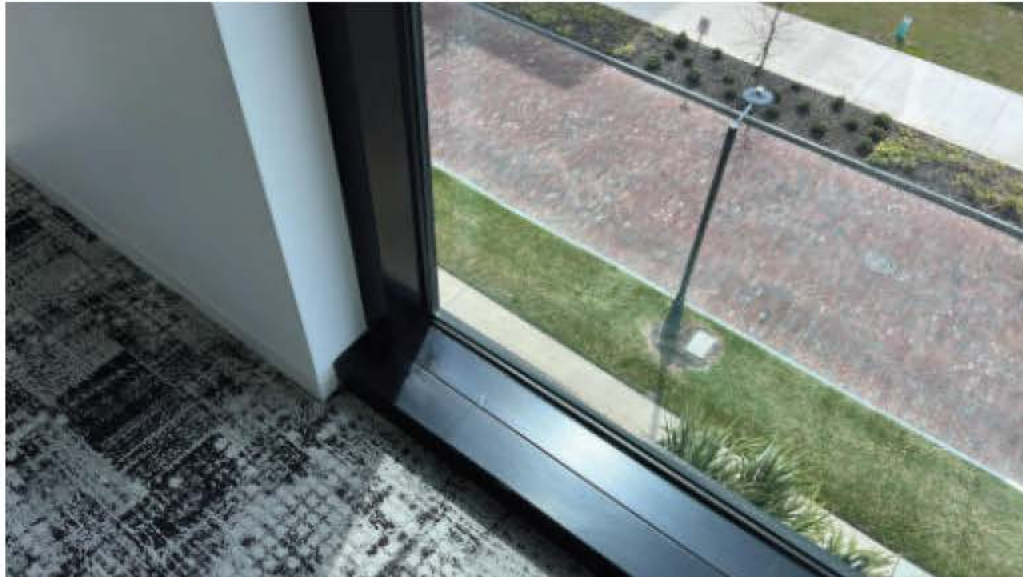
Picture 94: South elevation,
Evidence of water intrusion

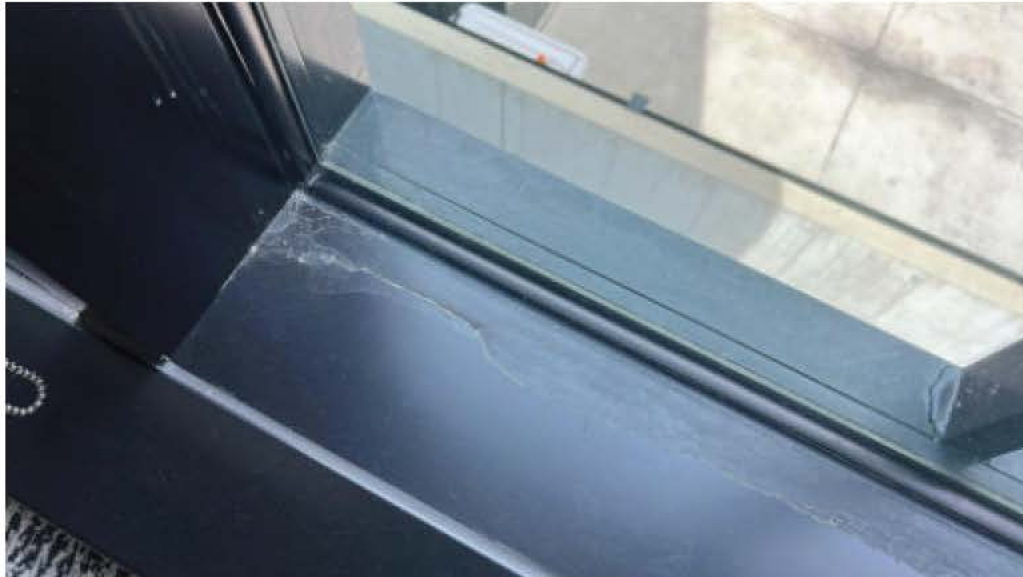
Picture 98: North elevation,
Evidence of water intrusion

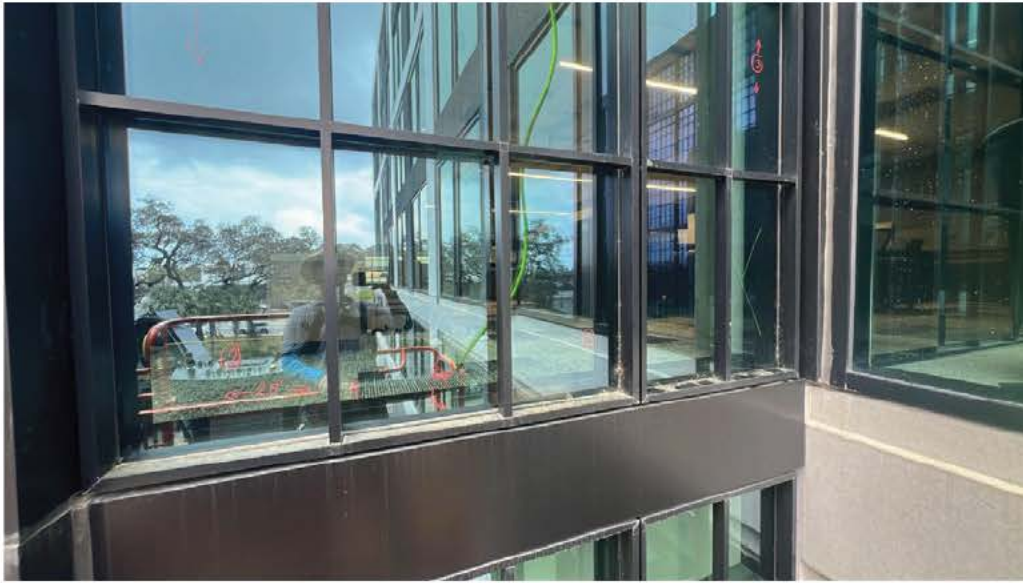
Picture 1: Overview of test location on 3rd floor. Test 1-4

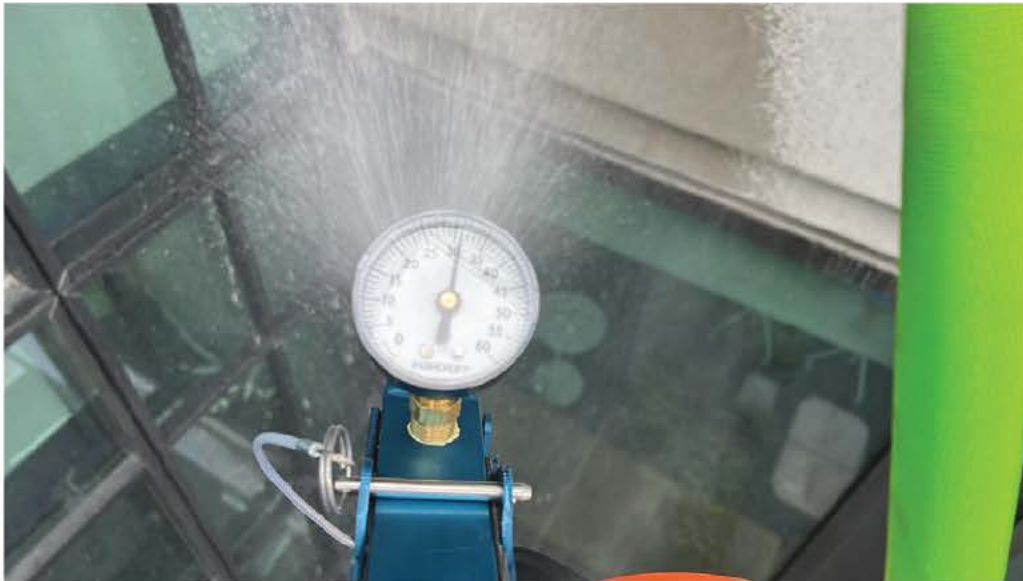
Picture 2: Pressure between 30 and 35 psi

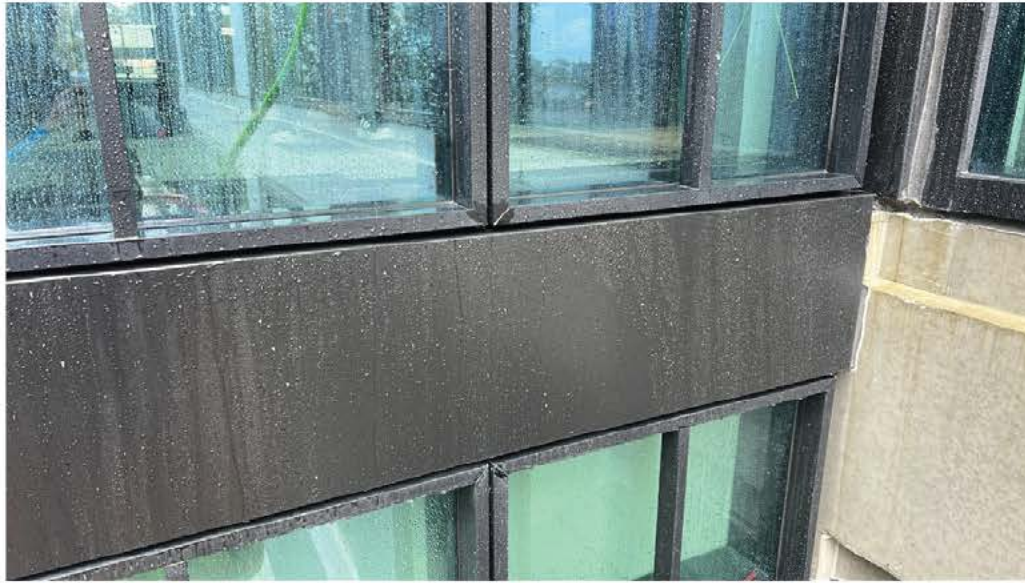
Picture 3: Conclusion of test 1, for 5 minutes. No water intrusion observed

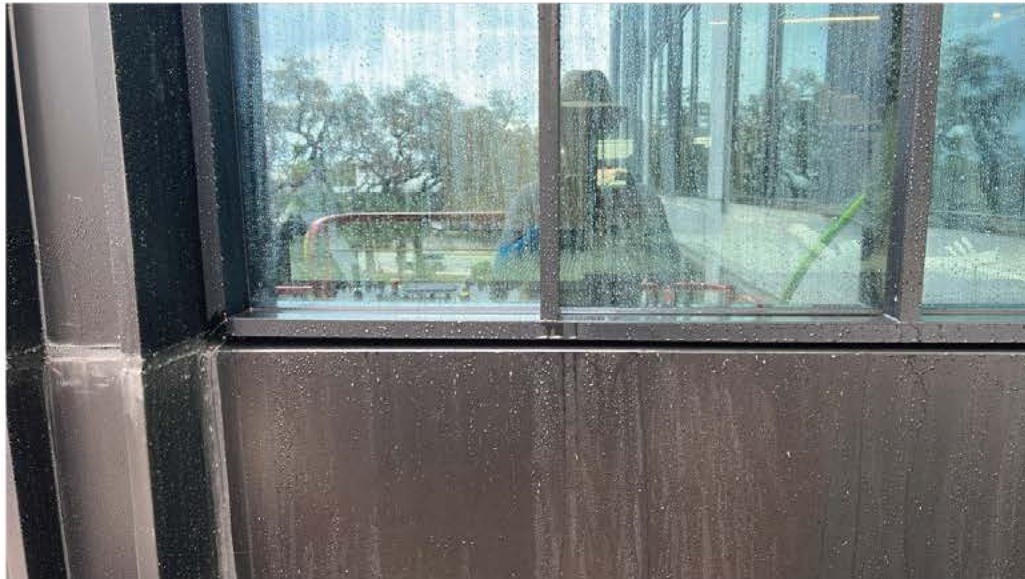
Picture 4: Conclusion of test 2, 2.5 minutes. No water intrusion observed

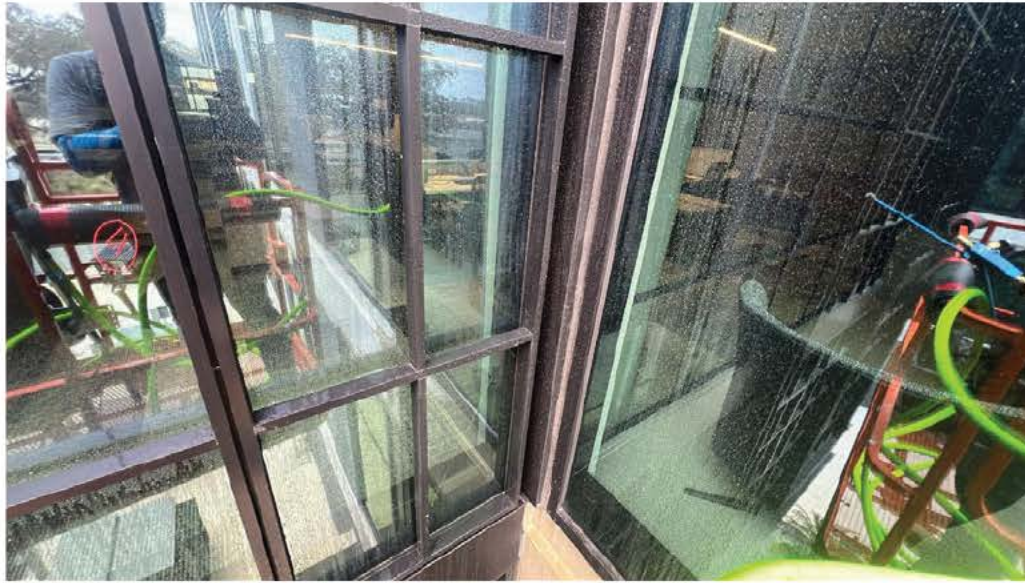
Picture 5: Test 3 at jamb. 5 minutes. No water intrusion observed

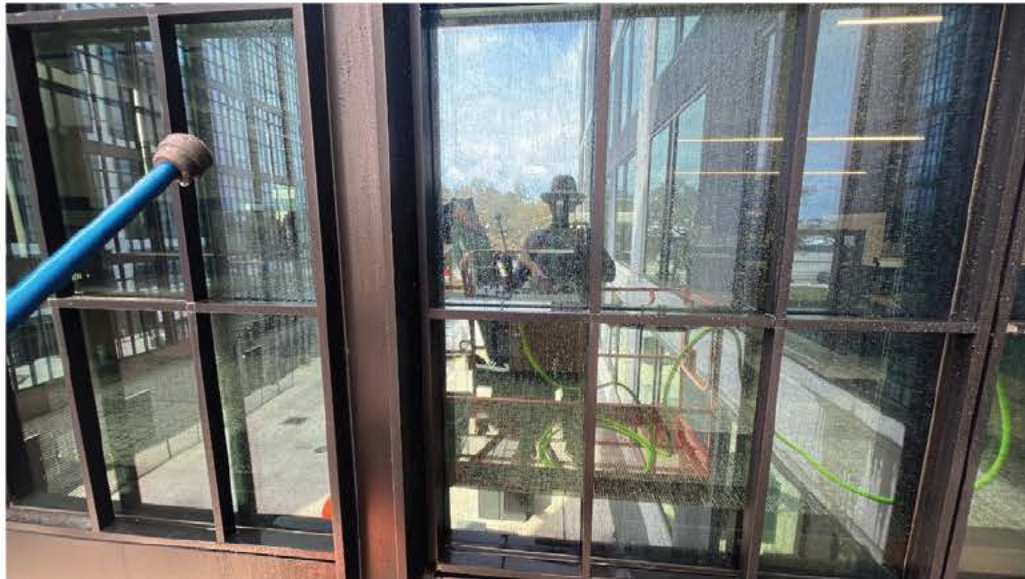
Picture 6: Conclusion of test 5. Left jamb. 5 minutes. No water intrusion observed

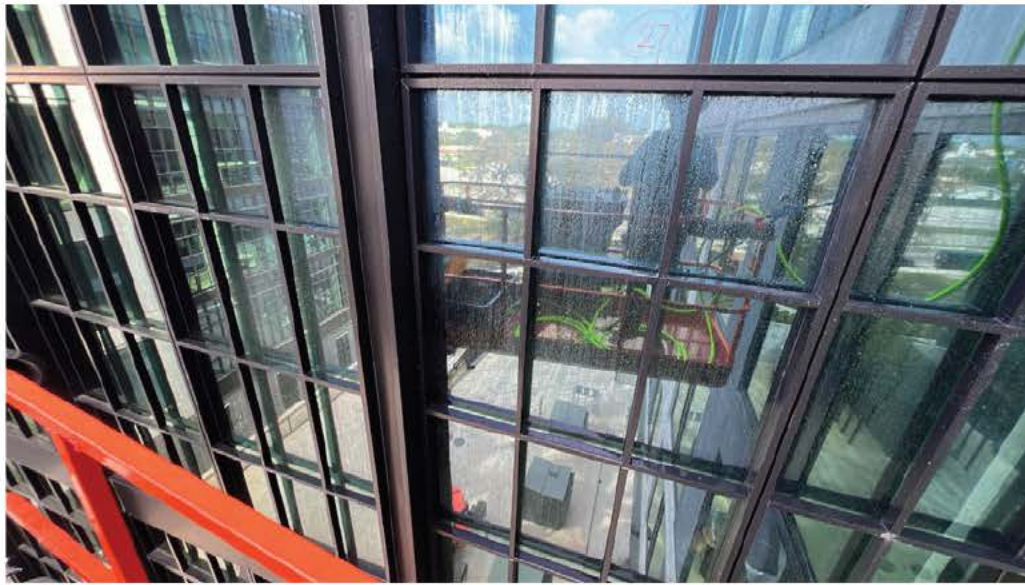
Picture 27: Conclusion of test 25, left jamb, 5 minutes, no signs of water intrusion.

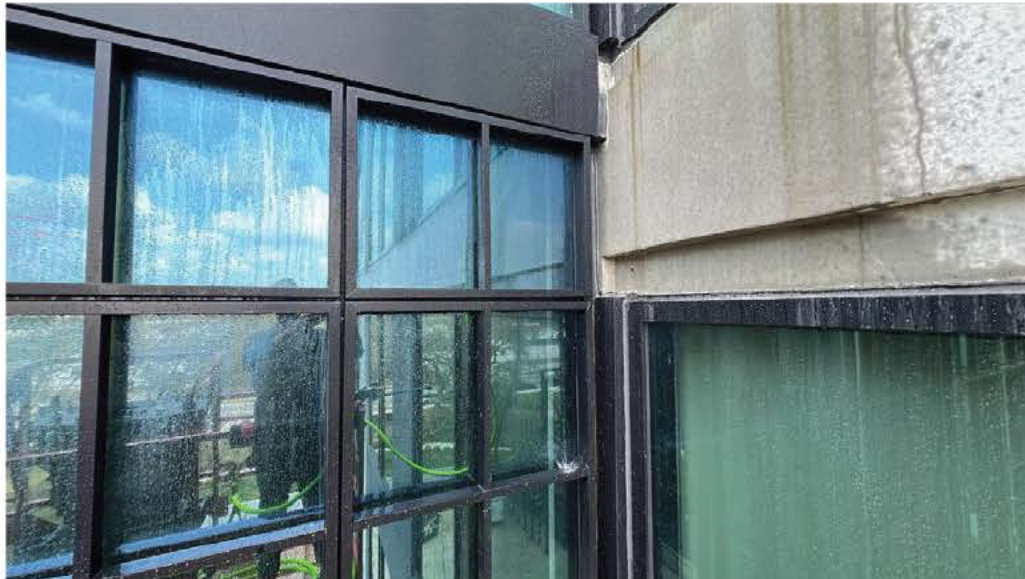
Picture 28: Conclusion of test 26, right transom, two and a half minutes, no signs of water intrusion.

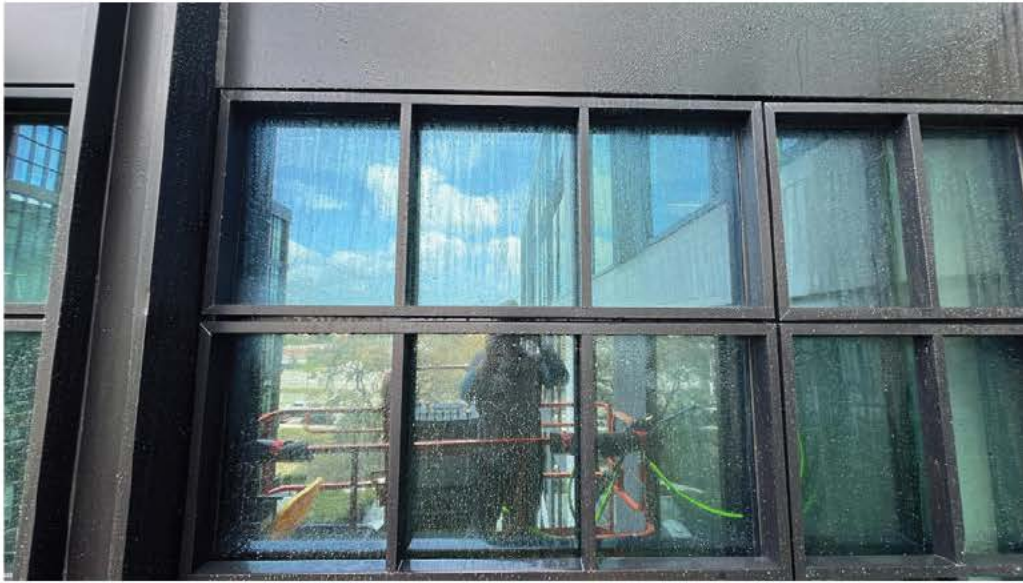
Picture 29: Conclusion of test 27. Left transom. Five minutes. No signs of water intrusion.

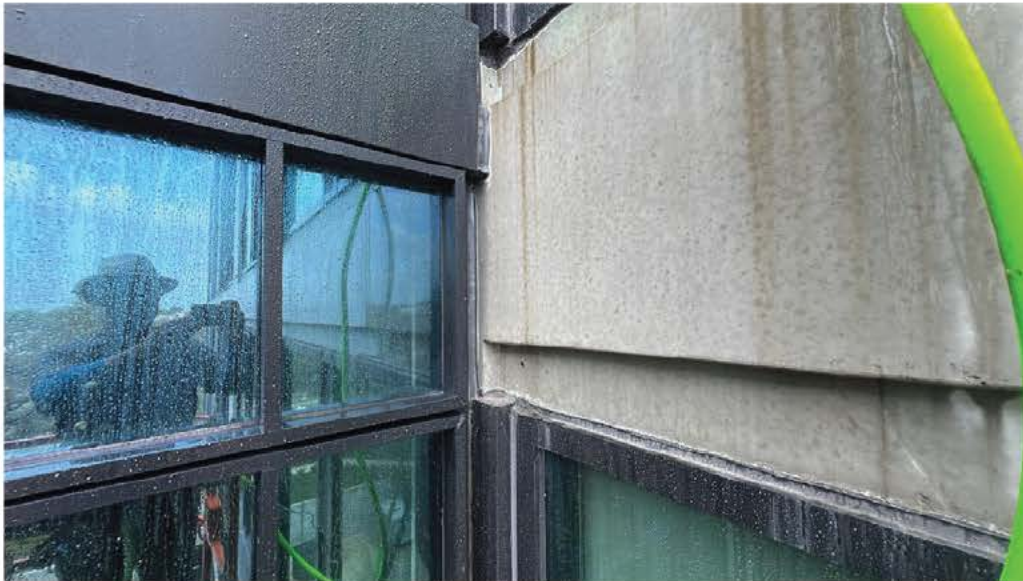
Picture 30: Conclusion of test 28. Right jamb. Two minutes. No signs of water intrusion.

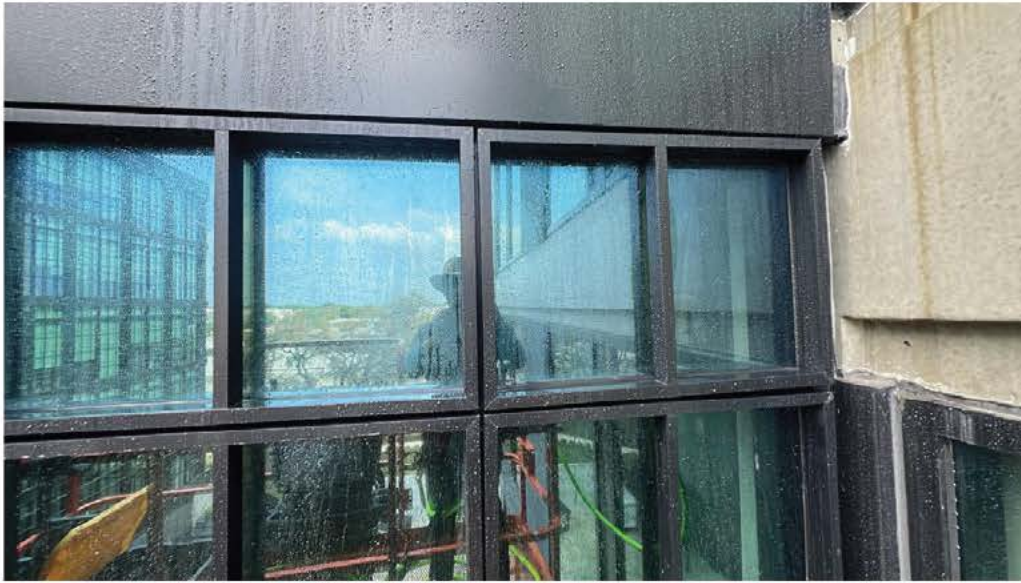
Picture 31: Conclusion of test 29. Two minutes. Mullion. No signs of water intrusion.

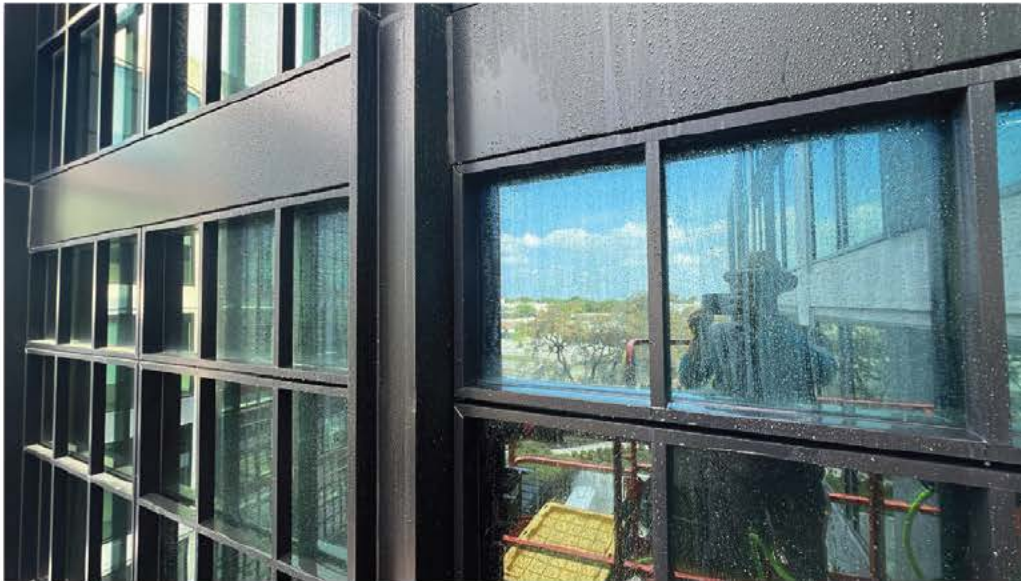
Picture 32: Conclusion of test 30. Two minutes, left jamb, no signs of water intrusion.

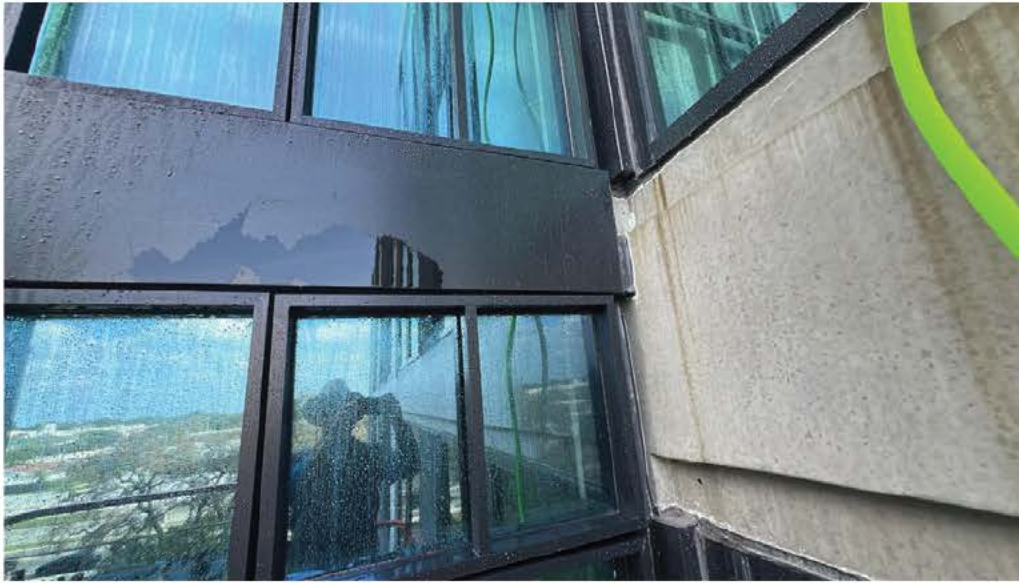
Picture 33: Conclusion of test 31, two and a half minutes, window head, no signs of water intrusion.

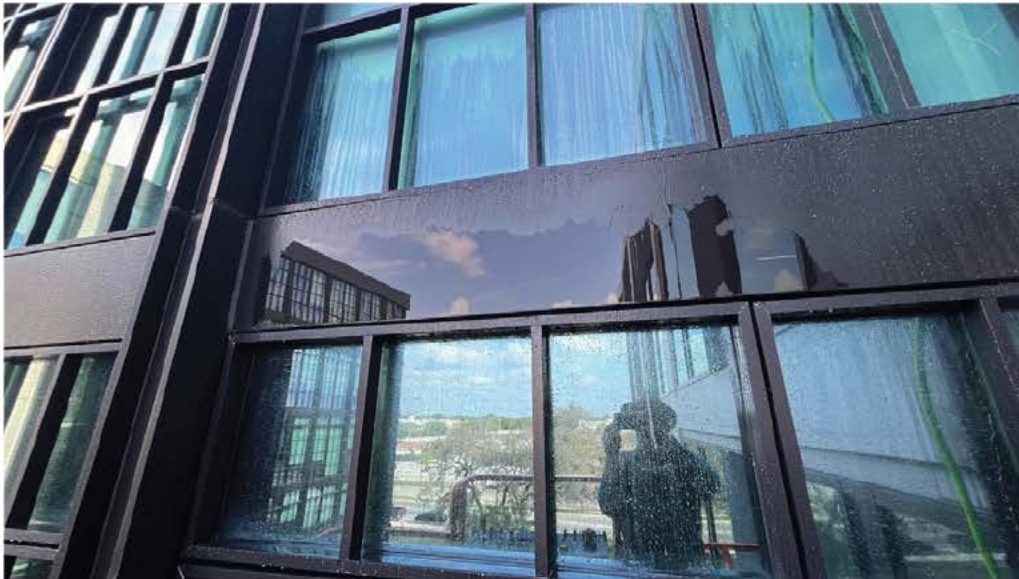
Picture 34: Conclusion of test 32, window head, 5 minutes, no signs of water intrusion.

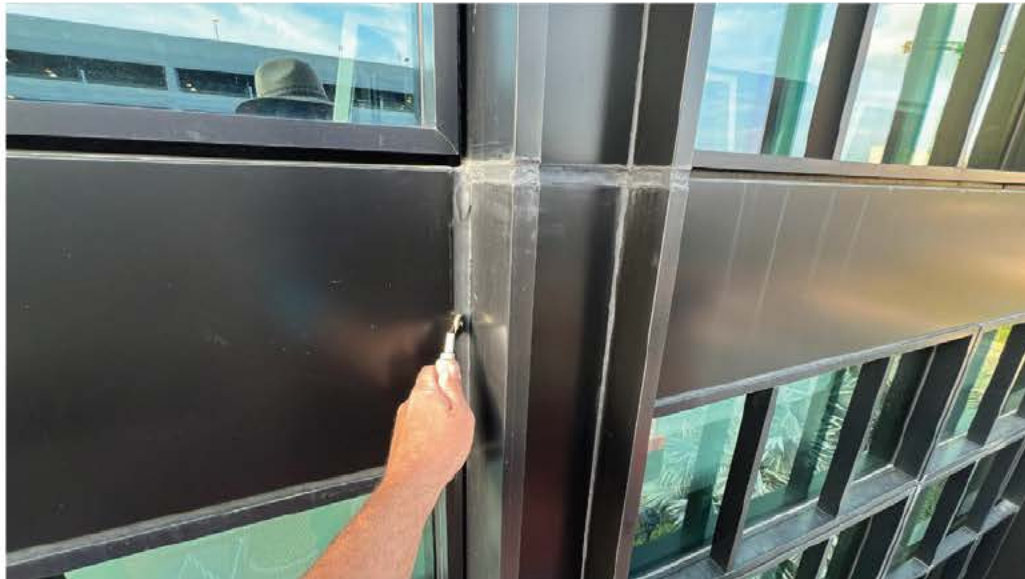
Picture 14: Sealants checked at isolated locations.

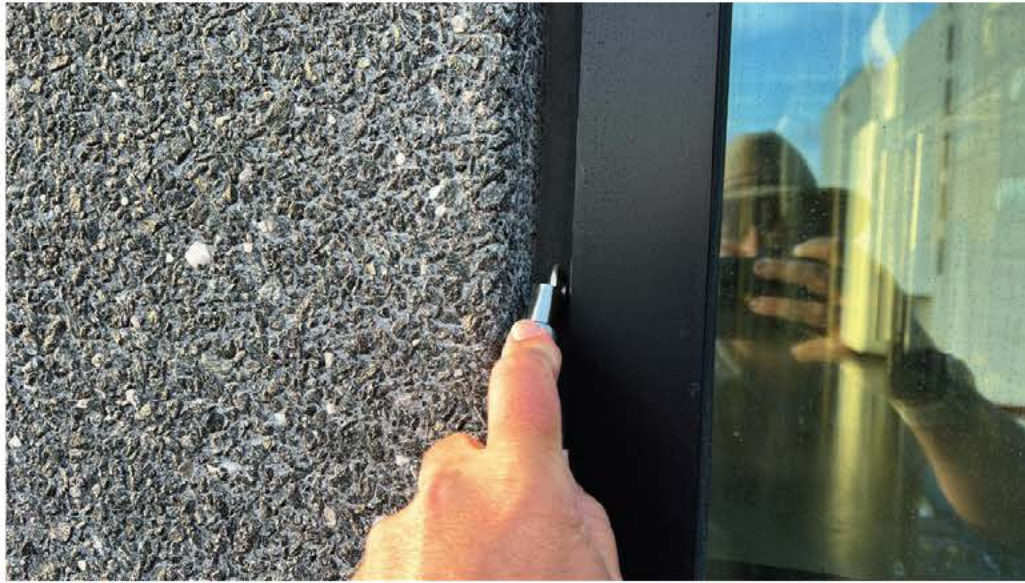
Picture 15: Sealants checked at isolated locations

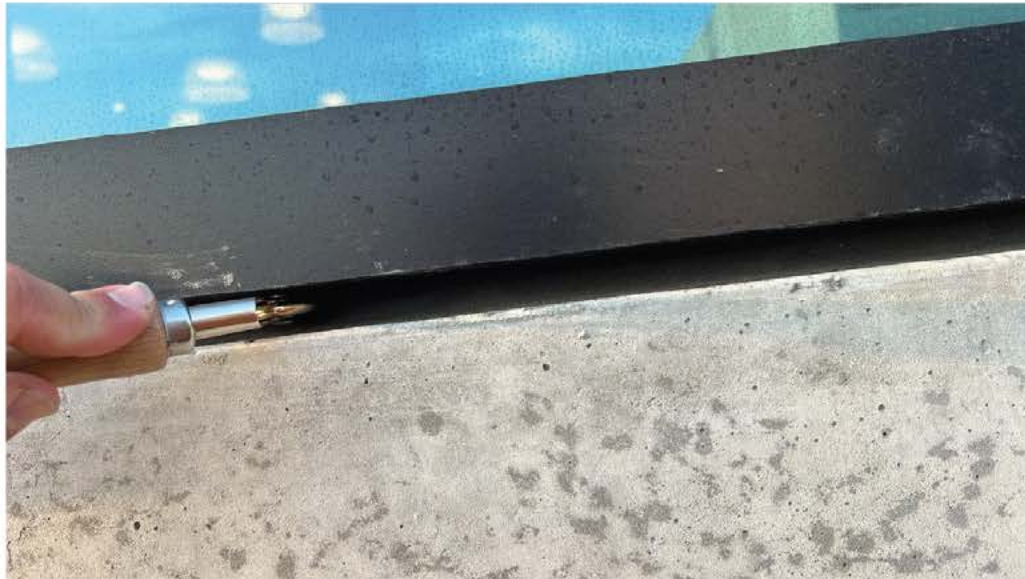
Picture 16: Sealants checked at isolated locations
